**INVESTIGATION REPORT**  
**RAW SEWAGE DISCHARGE TO THE RED RIVER**  
**CITY OF WINNIPEG**  
**NORTHEND SEWAGE TREATMENT PLANT**

**January 2003**

# **INVESTIGATION REPORT**

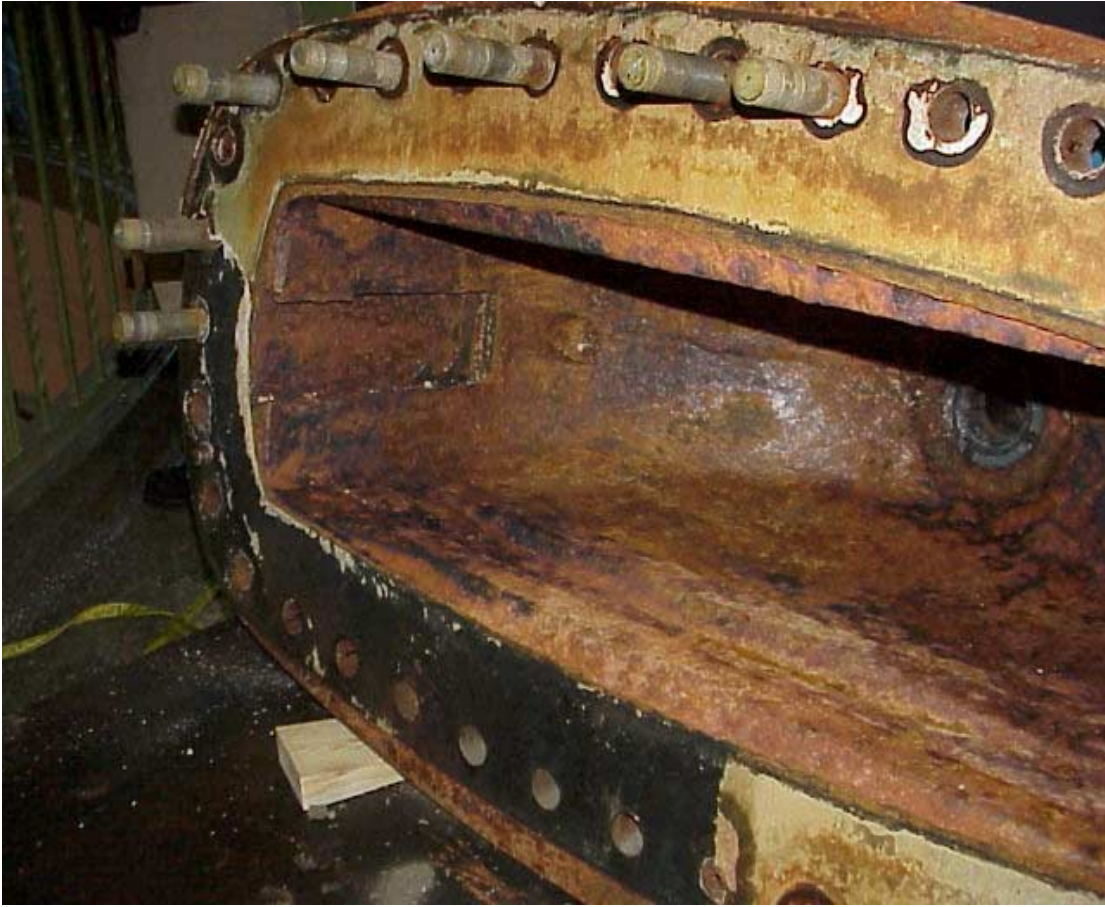
Photographs taken of the interior of the suction gate valve indicate the upper valve guide bar is absent and has moved to the lower portion of the valve body as shown in photos 511 and 516 respectively. The missing portion is 107 centimetres (42 inches) in length. The valve guides allow the valve plate to travel vertically and provide lateral support to the valve plate thereby preventing the valve plate from twisting or becoming misaligned. It is suspected that as a result of the missing guide the valve plate became misaligned, causing the valve plate to jam against the short valve guide now located in the lower part of the valve body and thereby preventing full closure of the valve plate. Coincidentally the valve was open a distance approximately equal to that of the length of the short valve guide.

Photo 511  
Top Bonnet of suction gate valve. Left side of interior of bonnet shows valve guide bar is missing.

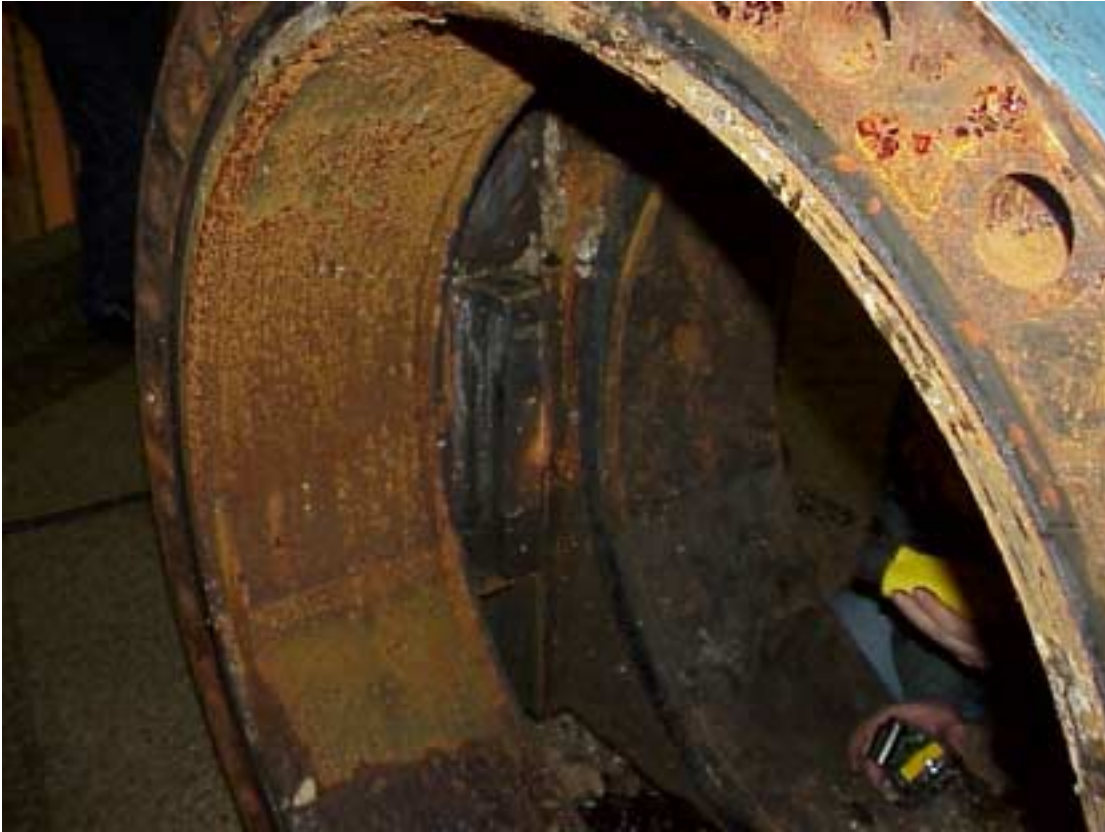
Photo 516

The upper valve guide bar, which is missing from the valve bonnet, as shown in Photo 511, is now positioned in the lower section of the valve body as shown in the above photo.
