**Environment Act Proposal  
(EAP) Form for the  
Argyle (Baldur) Existing  
Sewage Lagoon  
Report**

*April 29, 2013*

Environment Act Proposal Form (EAPF) for the  
Argyle (Baldur) Existing Sewage Lagoon

13-7248

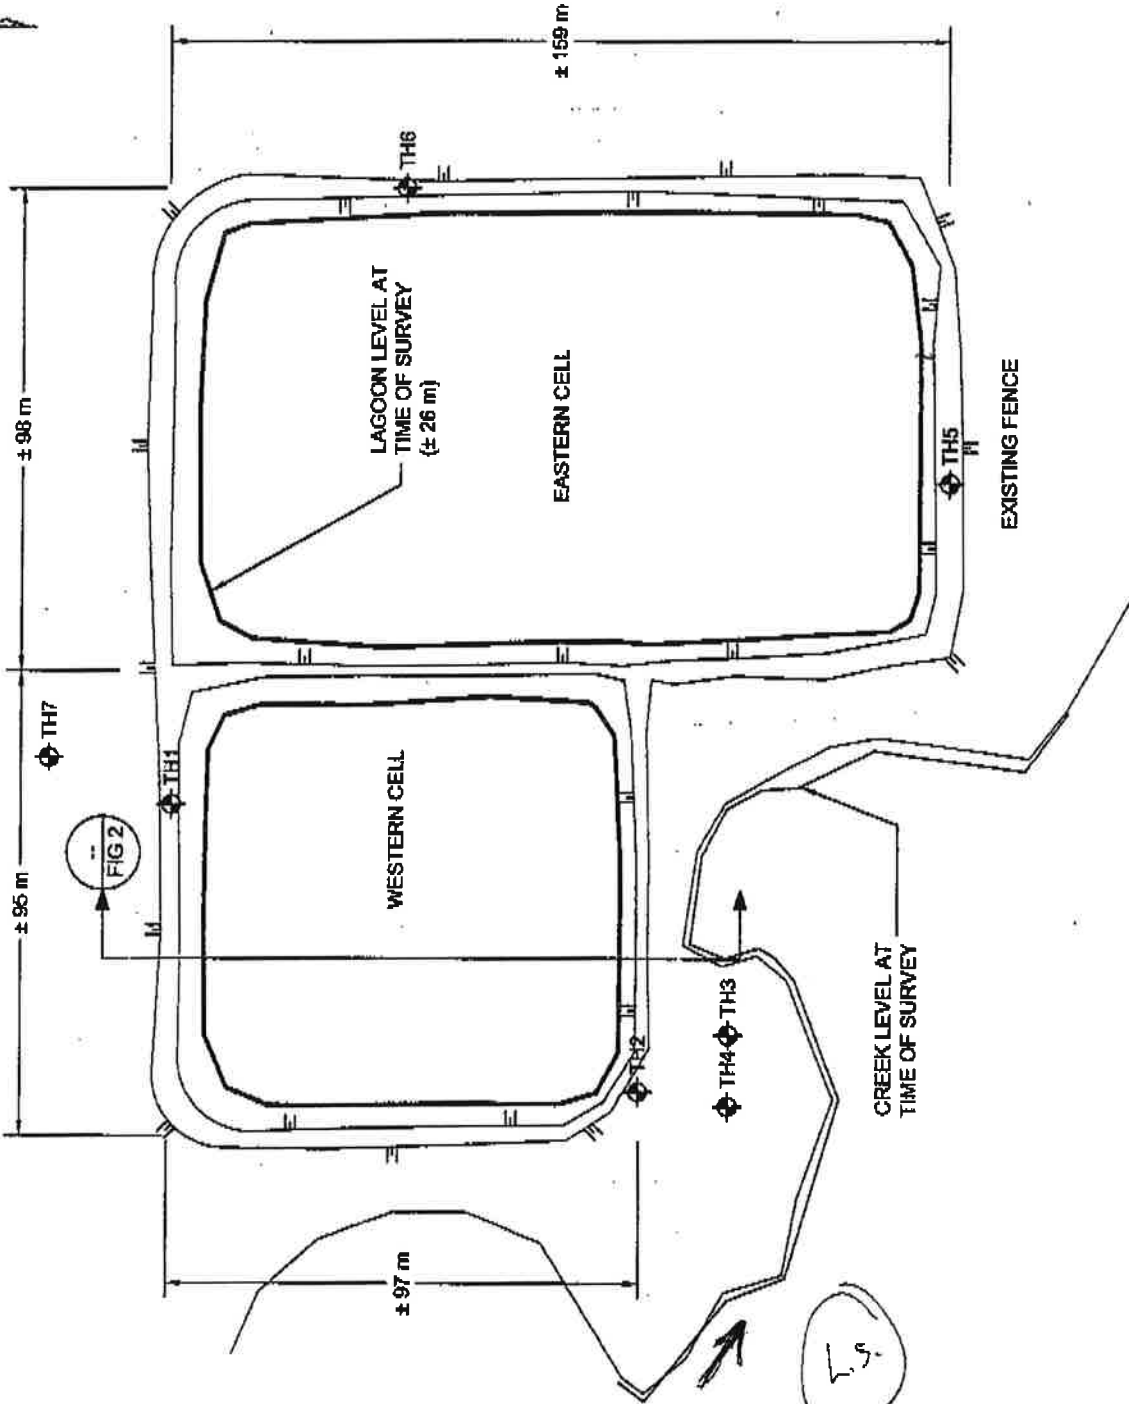
CLIENT:	STANTEC CONSULTING LTD.
PROJECT:	GEOTECHNICAL INVESTIGATION BALDUR LAGOON BALDUR, MANITOBA
ENG DESCRIPTION:	TEST HOLE LOCATIONS
SCALE:	NOT TO SCALE
DRAWN BY:	KWJ
DATE:	OCTOBER 2005
FILE NO.:	05-076-05
ENG-TECH DRAWING NO.:	1
REV.:	0

In general, seepage was observed in all test holes ranging in depths between 0.6 m to 2.7 m below grade (between elev. 24.1 and 25.9 m). More detailed descriptions of the stratigraphy are shown on the test hole summary logs attached.

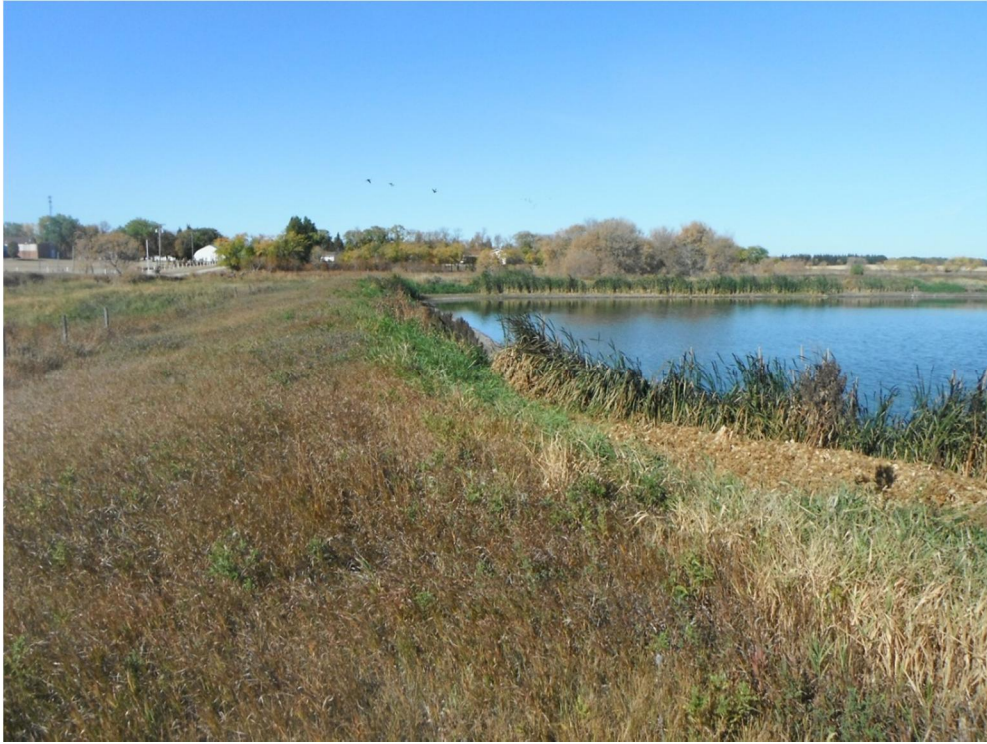
Perimeter Fencing seen on left; Lift Station in the background

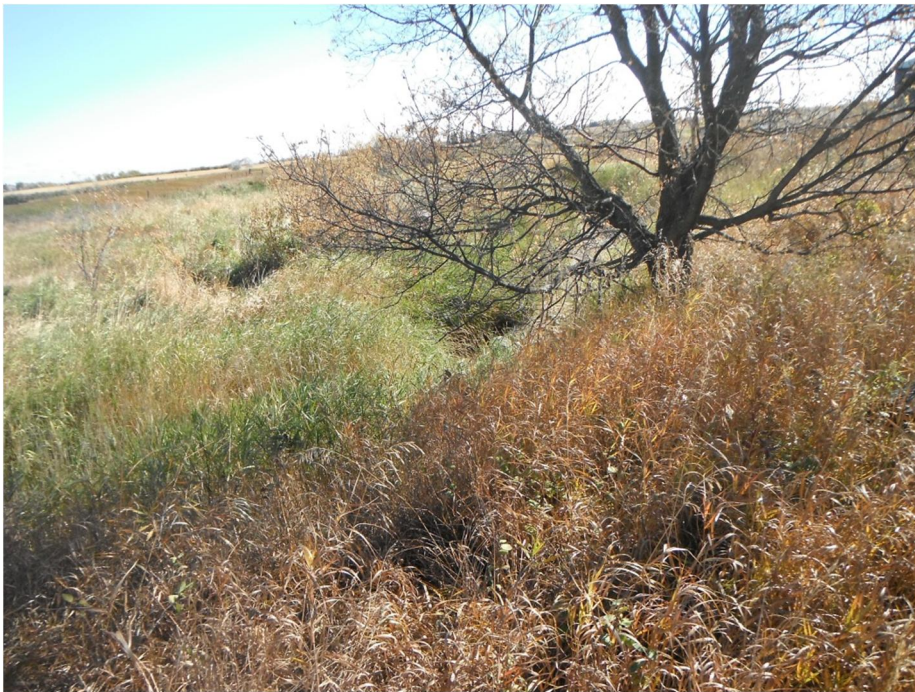
The Municipality conducted further investigation and found that the appearance of seepage was caused due to overloading of the lift station from the creek during spring floods. The RM took measures to fix the problem and there has not been any seepage around since then. This was confirmed during Dillon visit in Sept 2012.

Oak Creek Downstream of Lagoon: No flow indicative of no seepage

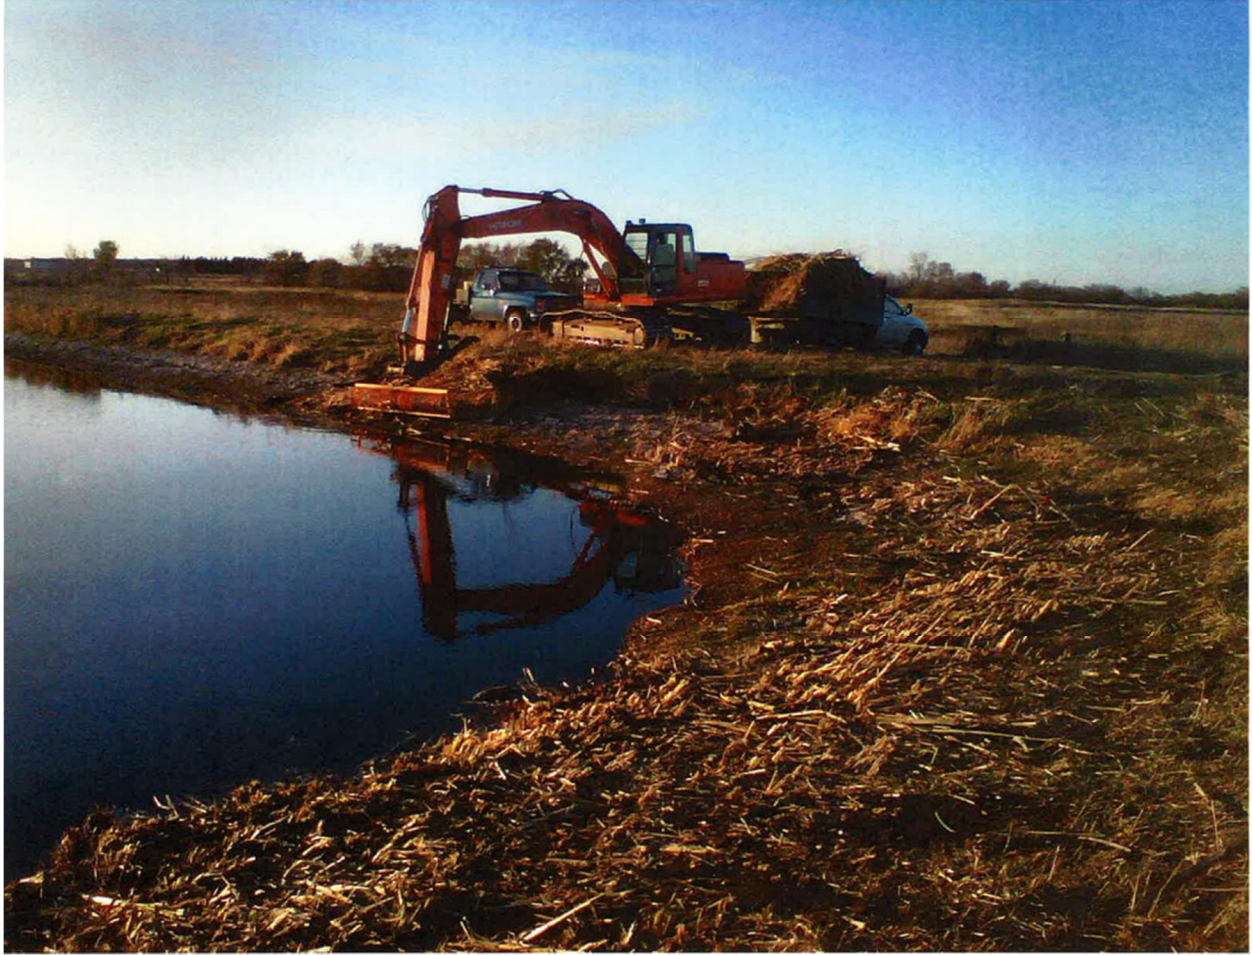
Clearing of excess growth at Baldur lagoon (2011)

It was noted in conversations with the R.M. of Argyle (LUD of Baldur) personnel that there has been no wastewater overloading since the above improvements and changes to the existing sewage lagoon have been completed. The water quality results of the wastewater effluent exiting the secondary lagoon cell shows that the effluent is meeting the required discharge criteria for discharge into the environment. TM personnel indicate that they will undertake to remove excess growth from the inside slopes on a periodic basis.
