Appendix B

Site Photos

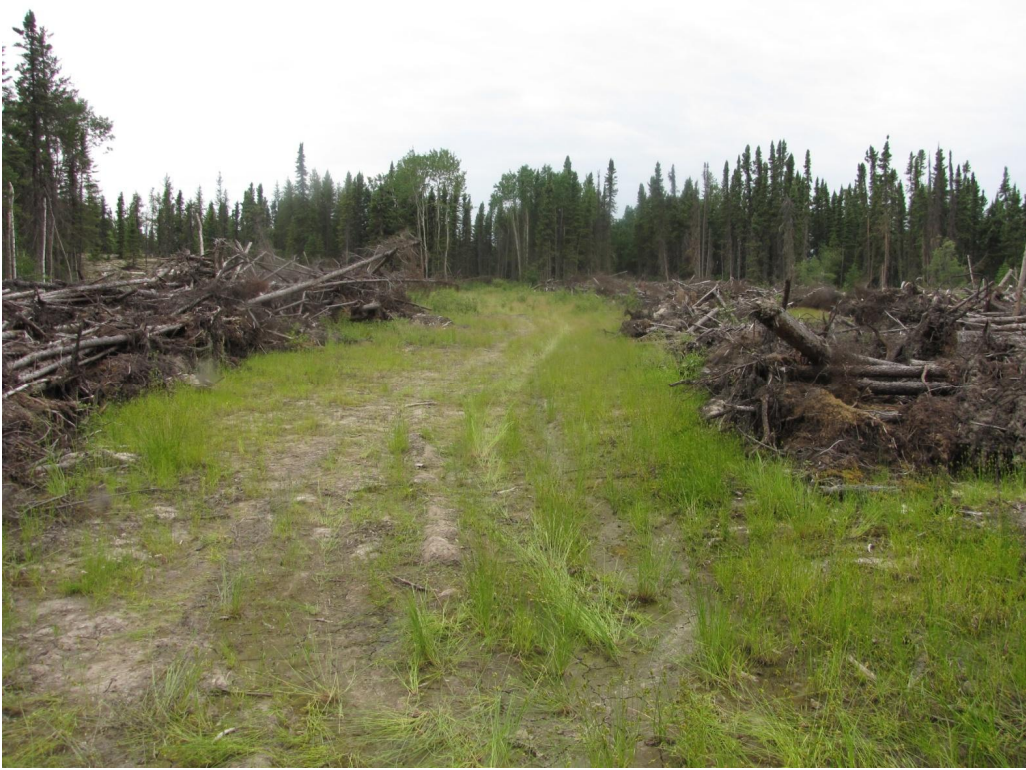
Photograph 1. Facing southeast showing cleared stand of black spruce developed on mineral soil at the location of the new lagoon ↑

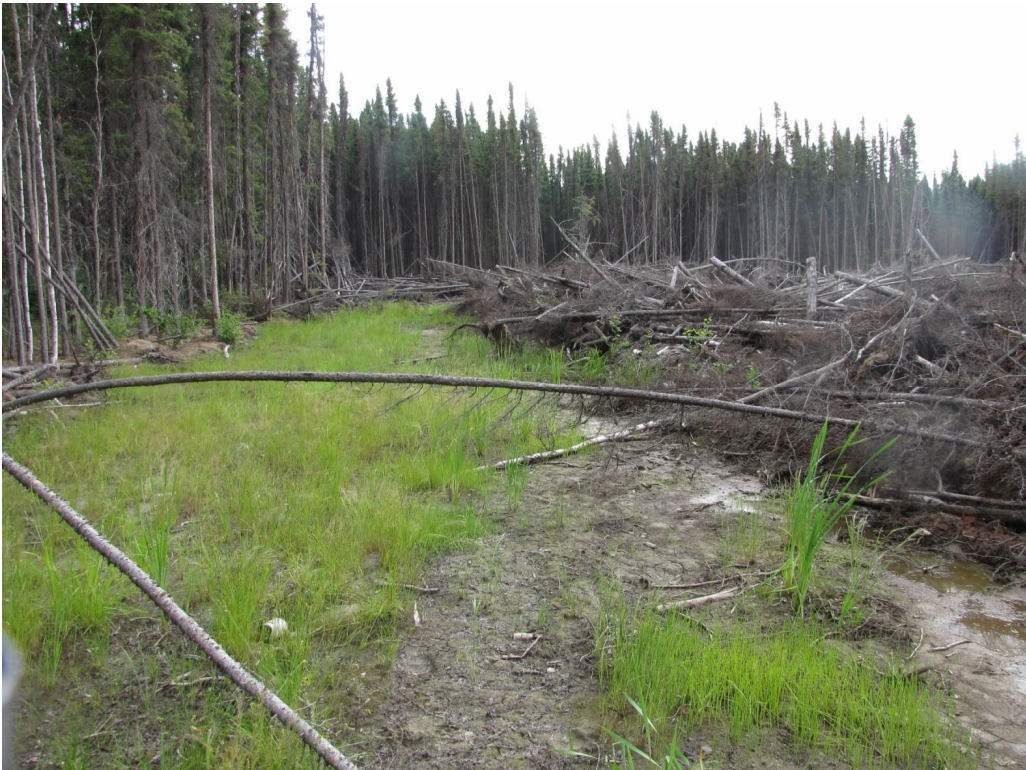
Photograph 2. Facing northeast showing lack of understory species at the location of the new lagoon ↑

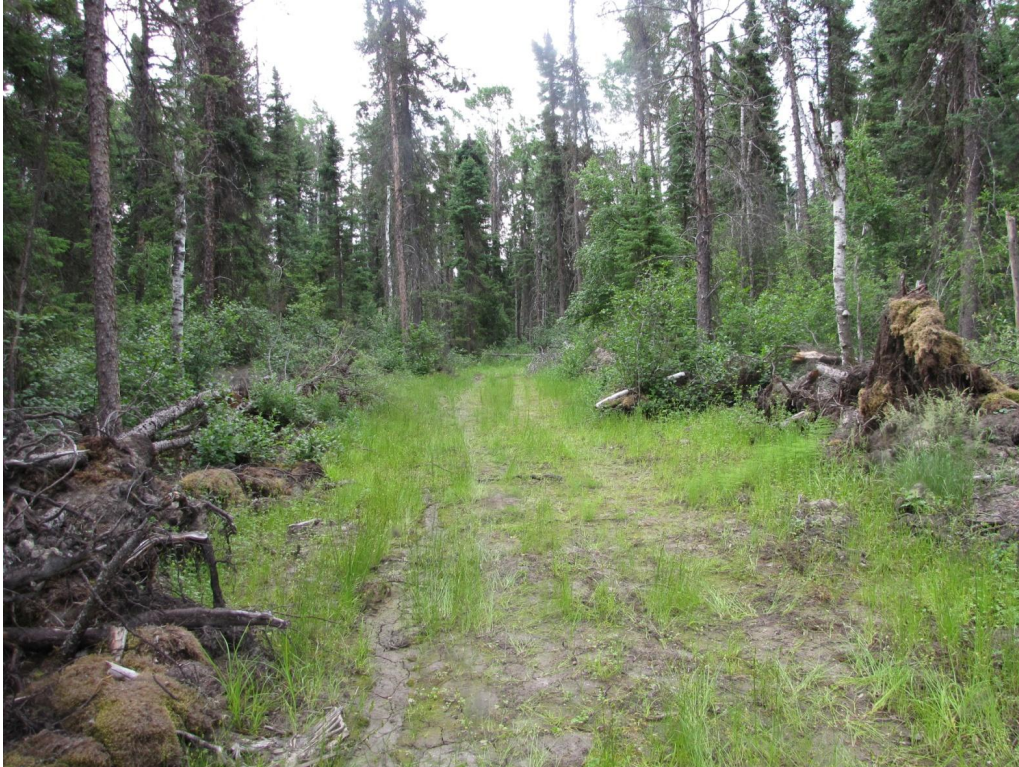
Photograph 3. Facing southeast showing transition from dense black spruce to mixed spruce aspen forest at the location of the proposed effluent discharge ditch ↑

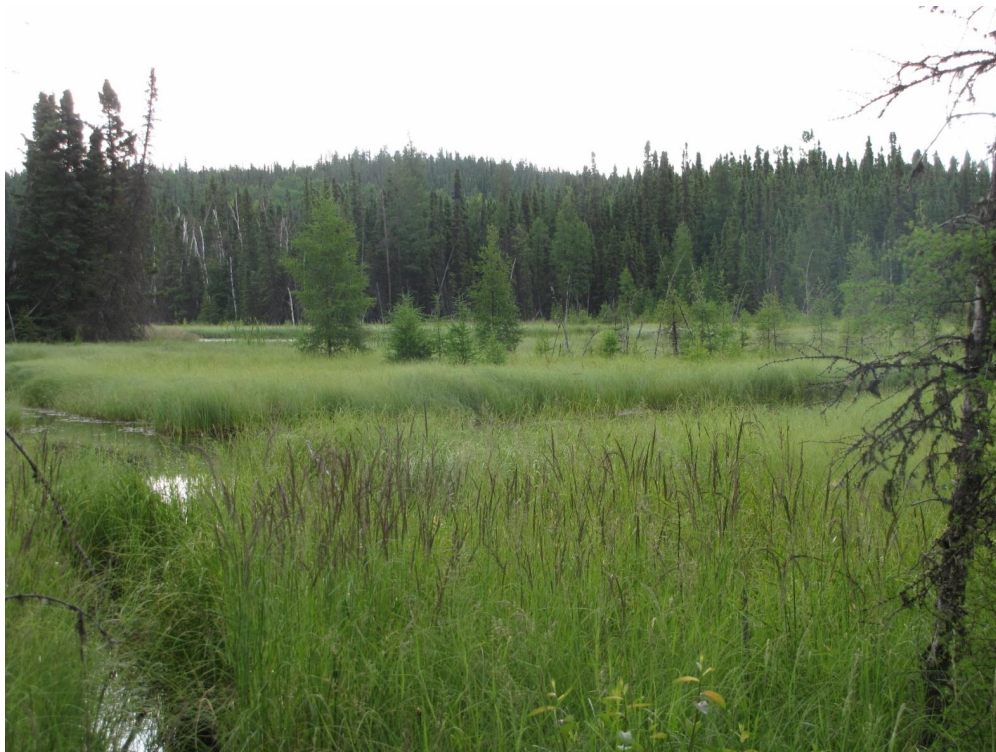
Photograph 4. Facing southeast showing the marshy lake and wet open bog at the terminus of the discharge ditch from the lagoon ↑

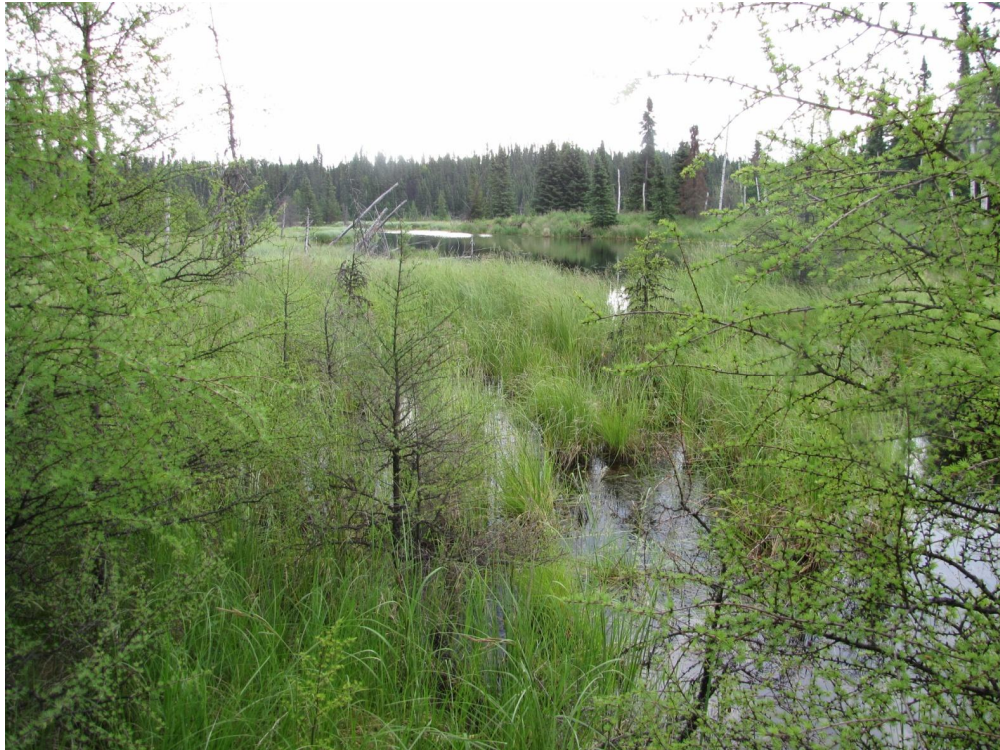
Photograph 5. Facing northeast showing the marsh and central rocky island with a tree cover of mixed spruce and aspen at the terminus of the discharge ditch from the lagoon ↑

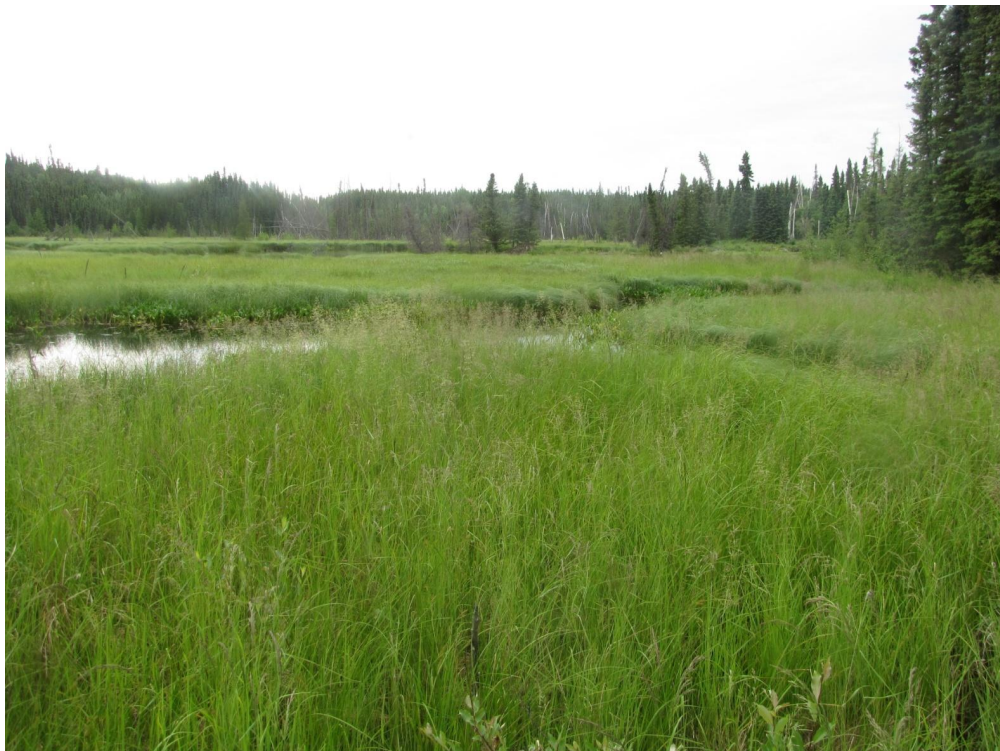
Photograph 6. Facing east showing the marsh and dense reed beds creating an open marsh structure attractive to waterfowl at the terminus of the discharge ditch from the lagoon ↑

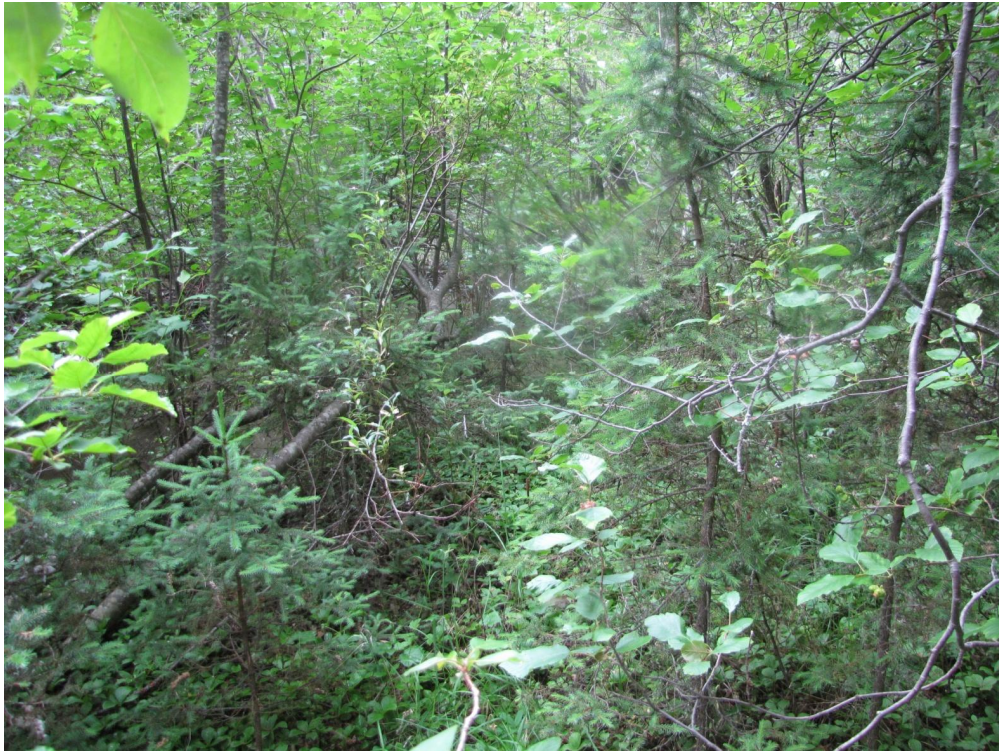
Photograph 7. Facing east showing the low lying boggy area at the outflow from the marsh along the natural drainage path to the Laurie River ↑

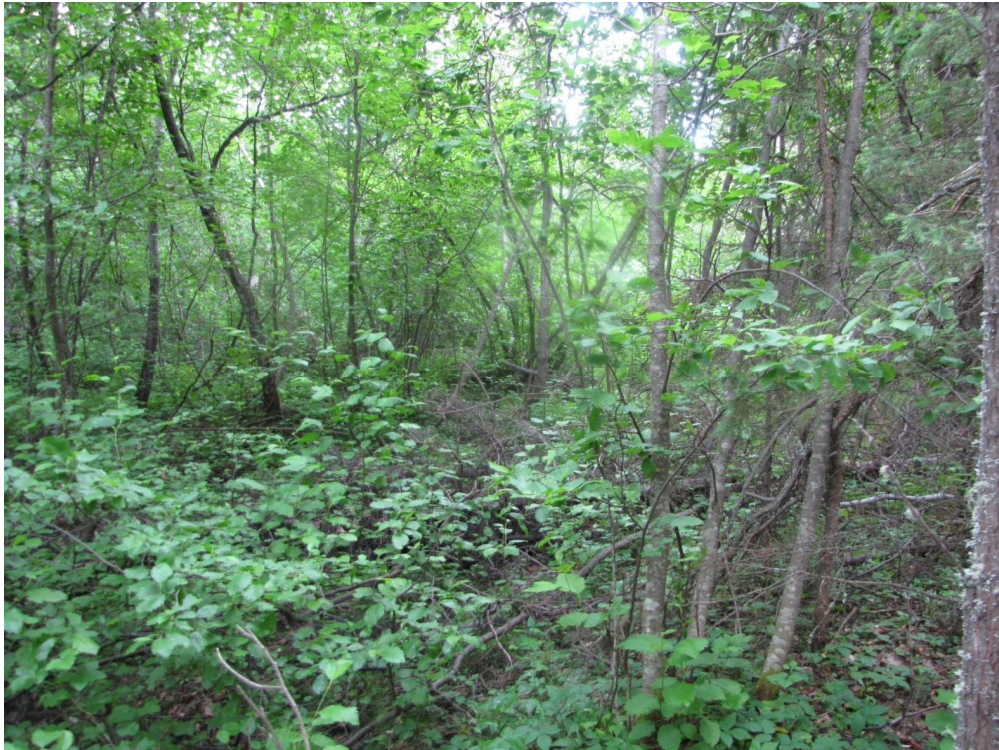
Photograph 8. Facing northeast showing the low lying boggy area at the outflow from the marsh in along the natural drainage path to the Laurie River ↑

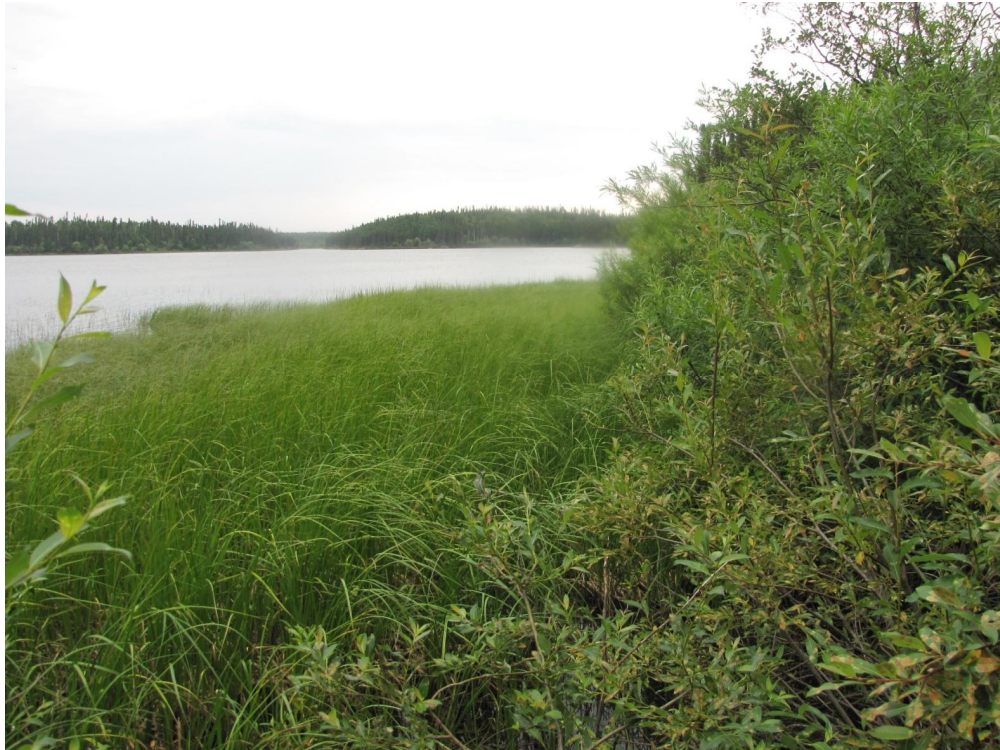
Photograph 9. Facing northeast at the Laurie River showing the location of the natural discharge point from the marsh ↑

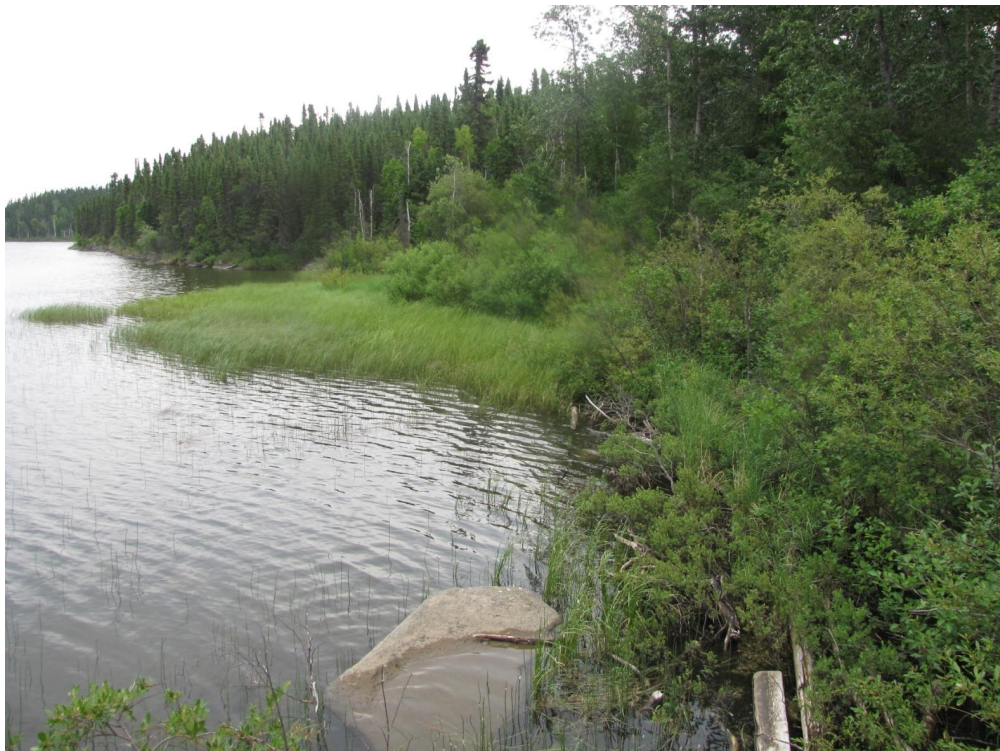
Photograph 10. Facing east at the Laurie River showing location of the natural discharge point from the marsh ↑

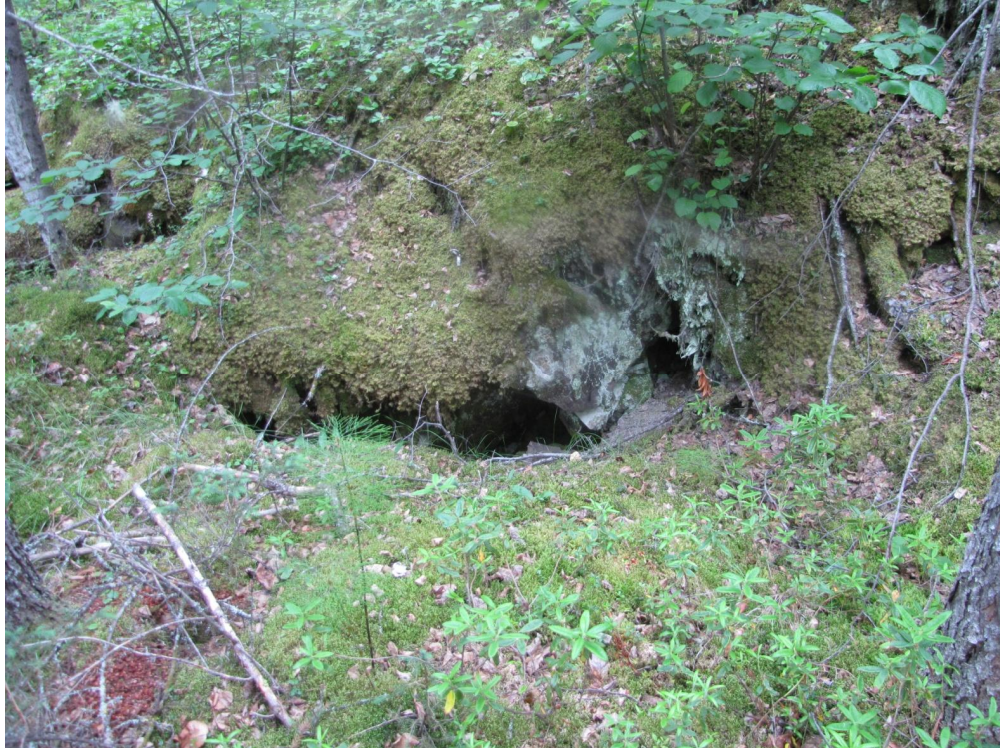
Photograph 11. Facing west showing erosion on channel between the marsh and Laurie River ↑

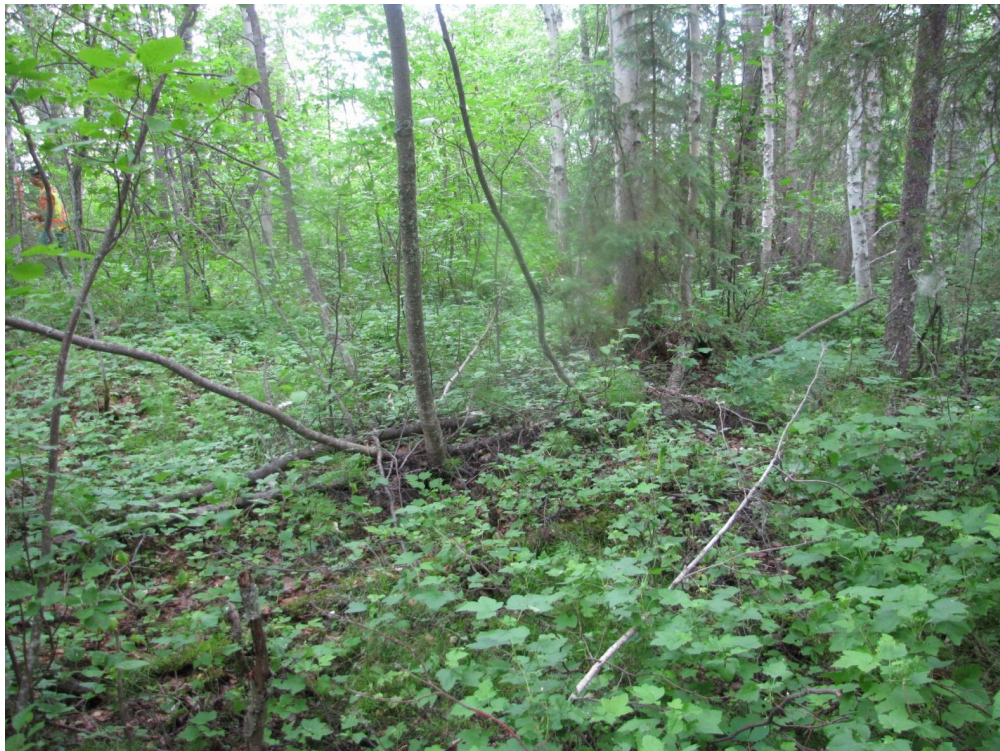
Photograph 12. Facing northwest showing well developed spruce and aspen stands with some shrubby growth along the erosion channel between the marsh and the Laurie River ↑

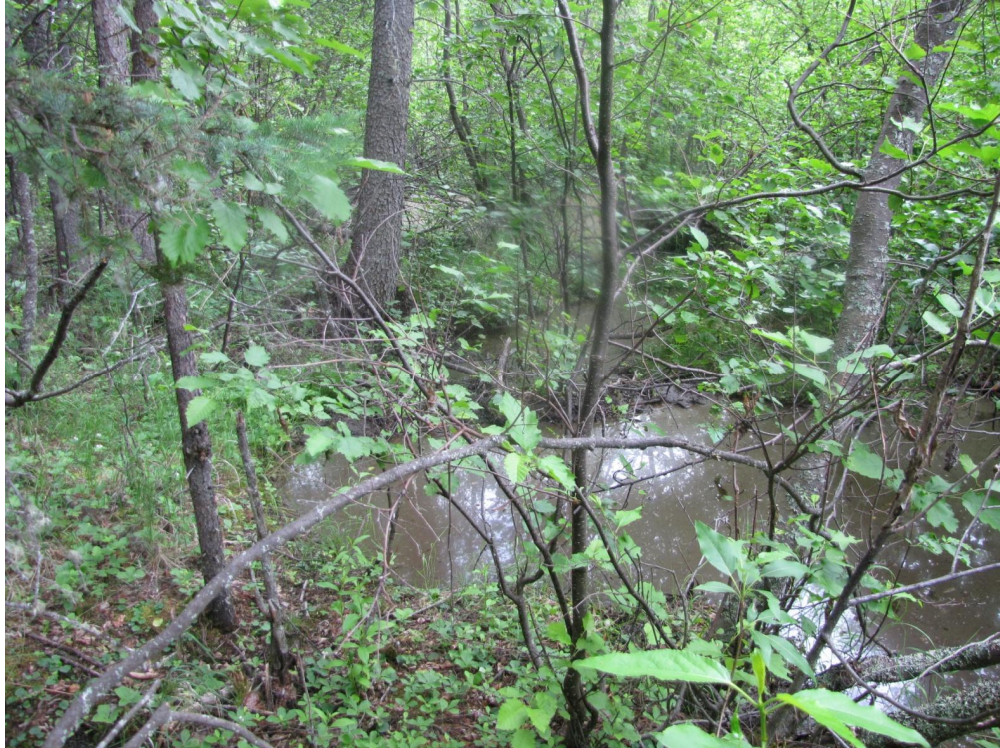
Photograph 13. Facing west showing evidence of beaver activity along outflow channel between the marsh and Laurie River ↑

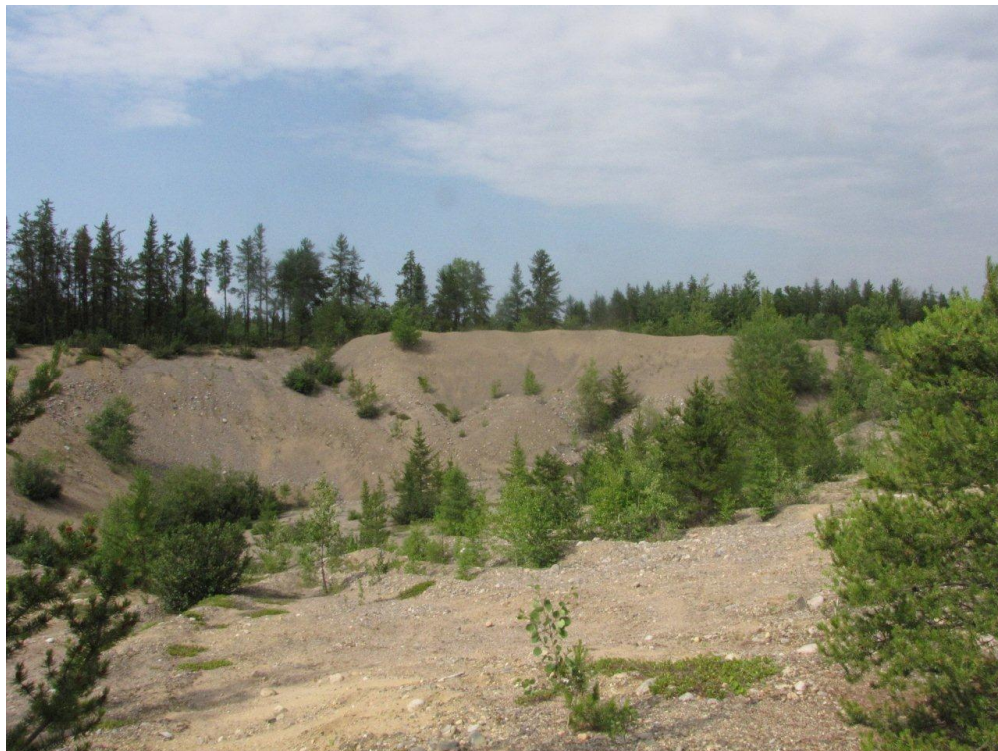
Photograph 14. View of existing potential borrow source ↑
