Table - 01: Summary of Aquatic Habitats Assessed in Project Area, 2011-2012

Stream Assessment - Site Card # LR01				
Assessment Date: June 4, 2011		Location		
Crossing # LR01		Watercourse Name Tern Ditch		
UTM 14U 6080710 N 427784 E				
		Site Description		Assessment
Upstream Waterbody: Tern Ditch Pond		Water Quality:		Fish Use
Downstream Waterbody: Snow Lake		Temp. (°C) 6.58		Spawning: Poor due to lack of suitable substrate for large-bodied fish but may provide limited habitat for forage species.
		pH 7.45		
Channel Width: 5 m		Cond (µS/cm) 161		Migration: Marginal due good connectivity to upstream habitat but low water levels may impeded passage.
Wetted Width: 5 m		Turbidity Clear		
Water Depth: 0.5 m				Rearing: Poor due to lack of suitable substrate.
Pattern: Straight				Over-wintering: Poor as this stream will likely freeze to bottom.
Characterization: Perennial				
Crown Cover: 0%		Surrounding Vegetation: Upland vegetation includes grasses and mixed forest interspersed with wetland areas.		Aquatic Habitat Sensitivity

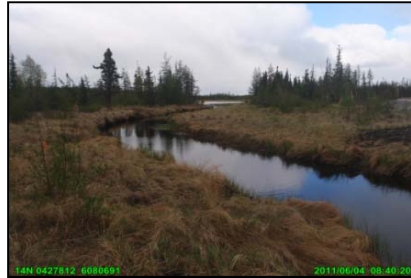
Photo 1: Stream crossing LR01, looking south with Tern Ditch in the background

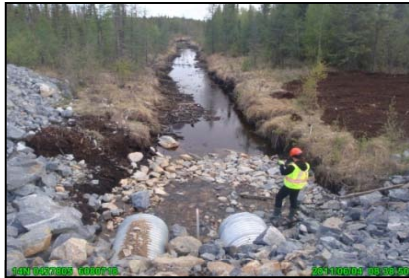
Photo 2: Stream crossing LR01, looking north

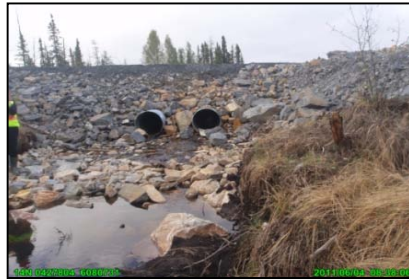
Photo 3: Stream crossing LR01, looking south

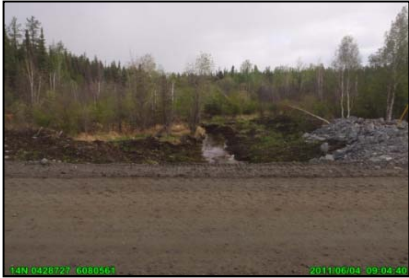
<p>Photo 1: Stream crossing LR02, looking north</p>		Crossing #	LR02	
		UTM	14U 6080558 N 428726 E

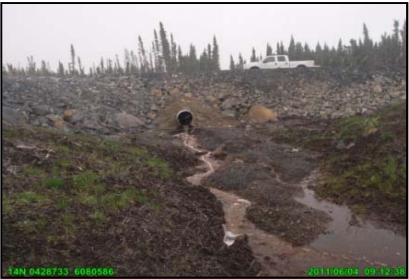
<p>Photo 2: Stream crossing LR02, looking south.</p>		Watercourse Name		N/A
		Site Description		Assessment

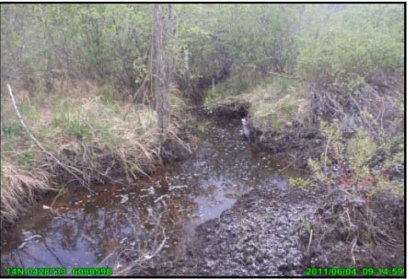
<p>Photo 3: Stream crossing LR02, looking north</p>		Upstream Waterbody:	None	Water Quality: Temp. (°C) 4.44 pH 6.83 Cond (µS/cm) 293 Turbidity Clear
		Downstream Waterbody:	None	
		Channel Width:	0.5 - 1.75 m	Surrounding Vegetation: Upland vegetation was a mix of deciduous trees, shrubs and grasses on the downstream (north) side. The upstream upland was more mature and consisted of deciduous and coniferous trees.
		Wetted Width:	0.5 - 1.75 m	
		Water Depth:	0.32 m	Unique Features: A white gelatinous material coated the bottom of the stream that ran over gravel near the culvert. It is suspected this material is flocculant used to remove suspended particles from suspension. There is a quarry approximately 300 m from the wetland area on the downstream (north) channel

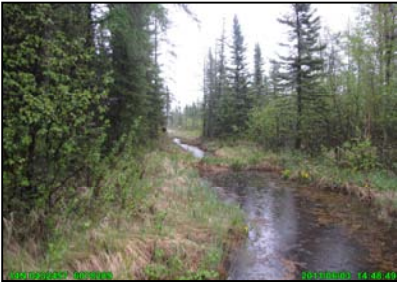
Upstream		Gaspard Creek
Figure 1: Stream crossing RB07, looking north		Waterbody:	None	Assessment
Figure 2: Stream crossing RB07, looking east, the channel follows the road until dispersing into wetland.		Downstream	Gaspard Lake	
Figure 3: Stream crossing RB07 looking southwest with some water bypassing the partially blocked culvert and crossing the road.		Channel Width:	0.5 - 1.75 m	Fish Use
		Wetted Width:	0.5 - 1.75 m	
		Water Depth:	0.32 m	Spawning:
		Pattern:	Straight	Poor for large bodied fish due to lack of suitable substrate.
		Characterization:	Perennial	Migration:
		Crown Cover:	10%	Good due to connectivity to upstream wetland.
		Substrate Type and Composition:	Organic 100%	Rearing:
		Cover Type and Composition:	LWD 5% OHV 30%	Poor due to lack of suitable substrate.

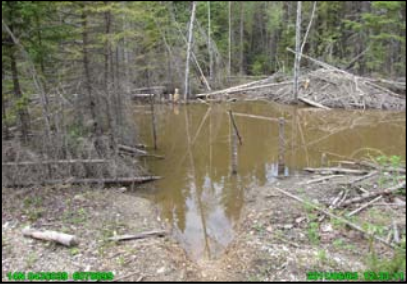
Figure 1: Stream crossing RB15 looking north into beaver impoundment.

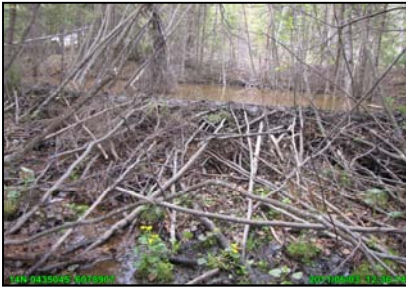
Figure 2: Stream crossing RB15, looking north with road in the background.

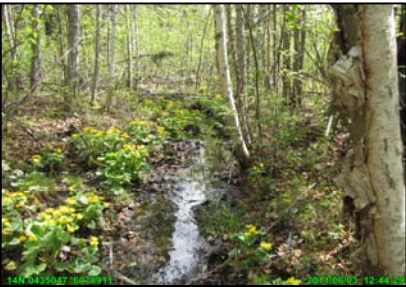
Figure 3: Stream crossing RB15 looking south.

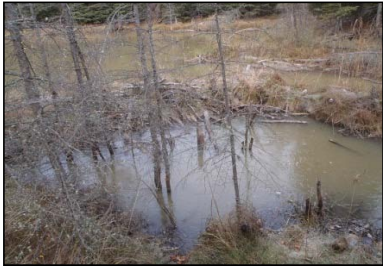
<p>Figure 1: Stream crossing RB16 looking north into beaver impoundment.</p>		Crossing #	RB16		Watercourse Name	N/A
		UTM	14U 6079369 N 435447 E

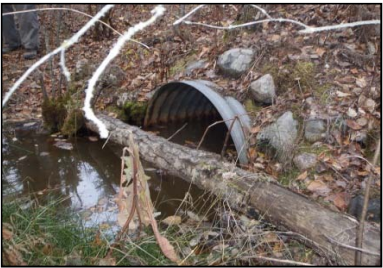
<p>Figure 2: Stream crossing RB16, culvert on the south side of the road</p>		Site Description			Assessment	
		Upstream			Water Quality*:

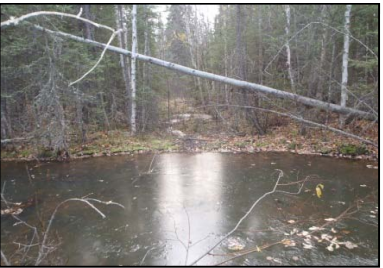
<p>Figure 3: Stream crossing RB16 looking south.</p>		Waterbody:	None		Temp. (°C)	16.1
		Downstream	None		pH	7.82
		Waterbody:	None		Cond (µS/cm)	136
		Channel Width:	1.0 - 5.0 m		Turbidity	Clear
		Wetted Width:	1.0 - 5.0 m		*Taken June 3, ice covered Oct 19	
		Water Depth:	1.0 m			
		Pattern:	Straight		Surrounding Vegetation: The creek is surrounded by coniferous and mixed forest.	
		Characterization:	Intermittent		Unique Features: A beaver has created a dam along the north side of the road creating a beaver impoundment that stretches for several hundred meters. On the south side of the road there is a smaller 5 m by 5 m impoundment which then feeds a small creek. No culvert was found on June 3 but the south side of the culvert was found on October 19. The north side of the culvert was buried or underwater and not observed.

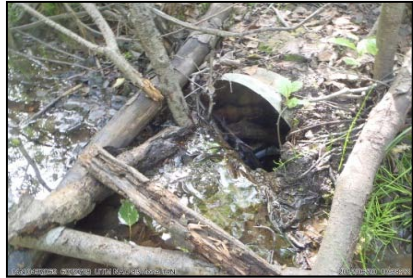
Figure 1: Stream crossing AD02, overgrown culvert.

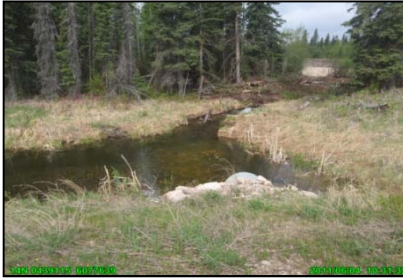
Photo 2: Stream crossing HWYAN, looking east (downstream).

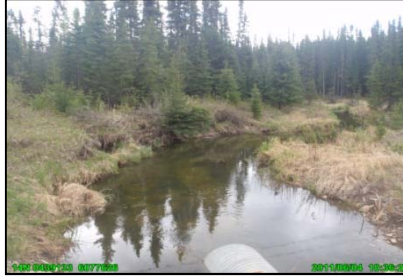
Photo 3: Stream crossing HWYAN, looking downstream.
