RM of Strathclair Salt Lake & Oak River Watershed

Hydrological Assessment for Flood Control Planning & Environmental Impact Assessment

From Field Work Data 2010-11

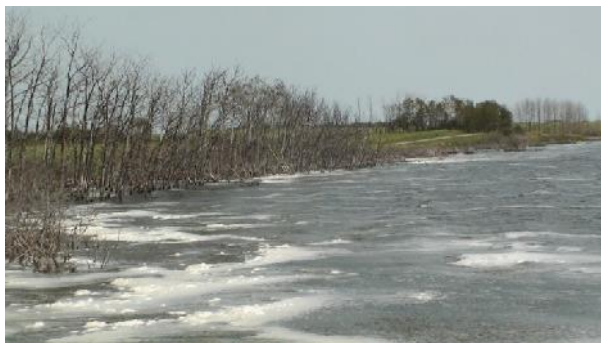
Figure 4 - Wave action and Turbidity - Center Salt Lake 2010

Wave action over shallow shoals creates strong turbidity in Center Salt Lake

In 2011 the water level increased more than a meter so the turbidity abated from lessened effects of wave action but evaporation was further inhibited.

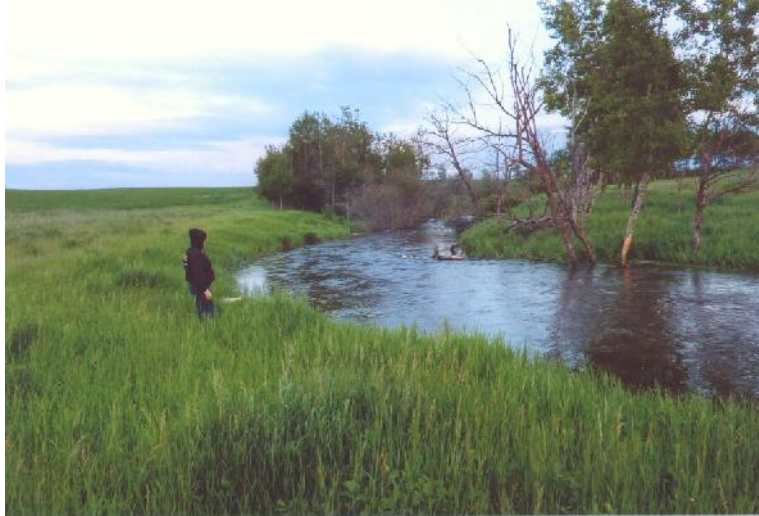
Figure 8 Uncontrolled water release 2010

A photo taken during the 2010 EMO discharge that bisects the Moffatt pasture.

Uncontrolled releases are sources of high erosion, hazardous to human activity and to livestock directly

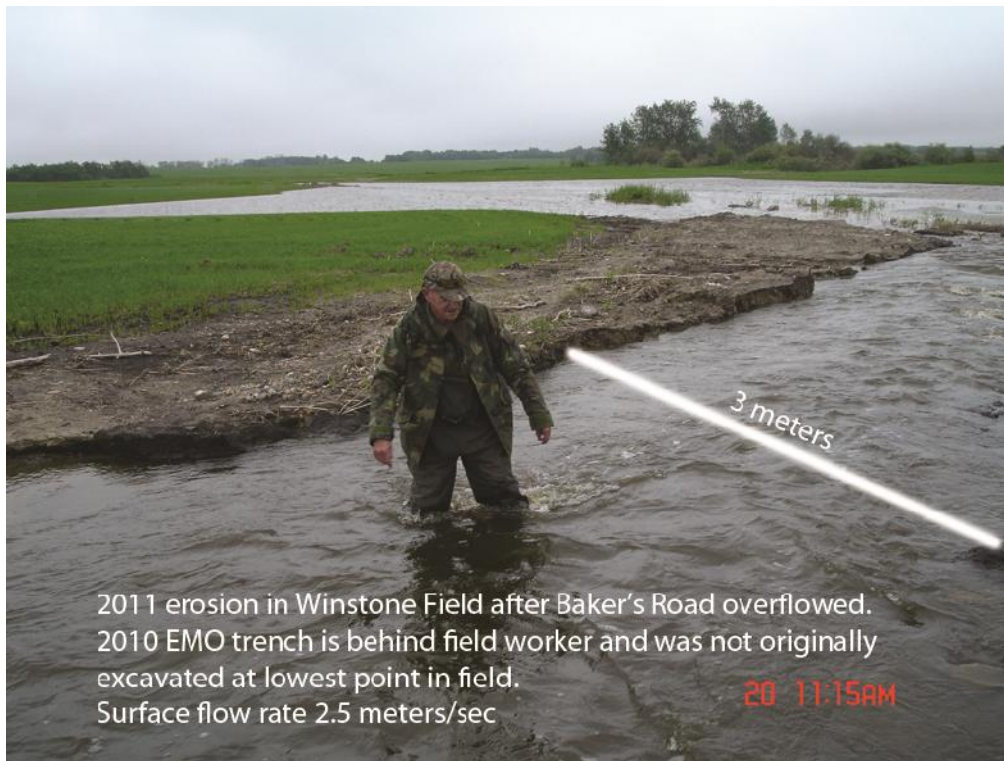
Figure 9 - Spontaneous uncontrolled overland flooding -3.374 cm³/sec - 2011

Baker's Road (Road 95N along the south flank of Section 27, Range 22, Twp 16) cannot be considered a barrier to the rising waters in Center Salt Lake. Nor can the Winstone field (NW1/4 of Section 27-16-22) contain it as proven in 2011. No holding capacity in Center Salt Lake will be available in the spring of 2012 and flooding will be immediate. However, in 2011, the Oak River System managed to contain the flow depicted here without overland flooding. However, the effect on South Salt Lake was disastrous.

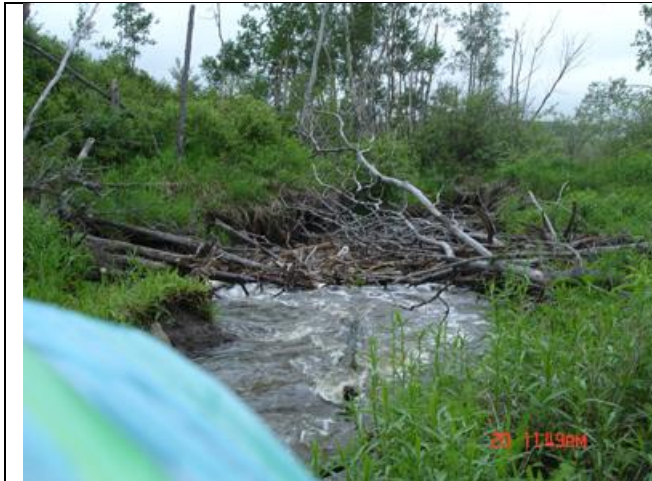
Figure 10 - Erosion in Moffatt valley- 2010 EMO route

Erosion is excessive in the valley utilized for EMO drainage in 2009 and 2010. When Baker's Road breached in 2011 the flow was somewhat less but erosion continued and there is no easy or economical way to address it. The route should not be used except in dire circumstances.

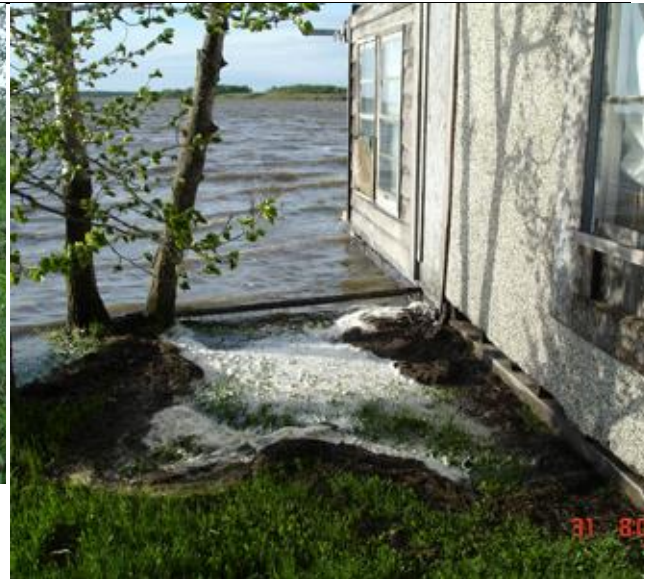
Figure 11 - Cabin flooded- South Lake 2011

A cabin on South Salt Lake. June20th, 2011. Similar damage or even worse can be expected in future if water levels in Center Salt Lake are not lowered and becomes a reservoir. Uncontrolled or spontaneous releases damage infrastructure.

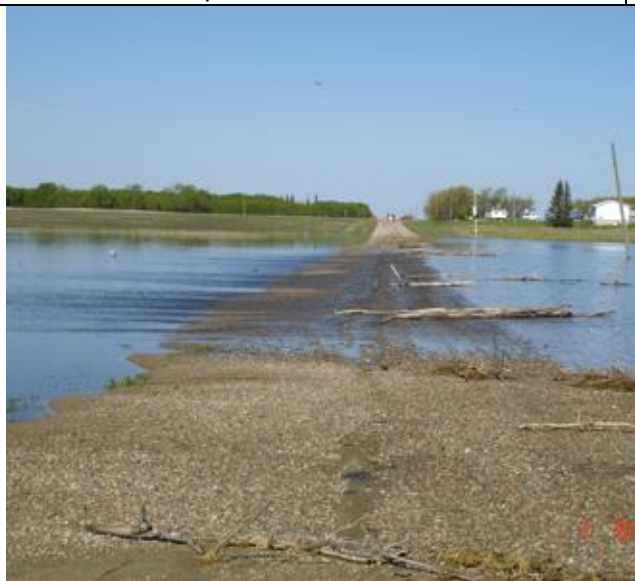
Figure 12 - Flooding and damage - Road 94N

Baker's Road - June 2011 - Unrestricted flow for 150 meters, plus whatever capacity the submerged culvert could discharge.

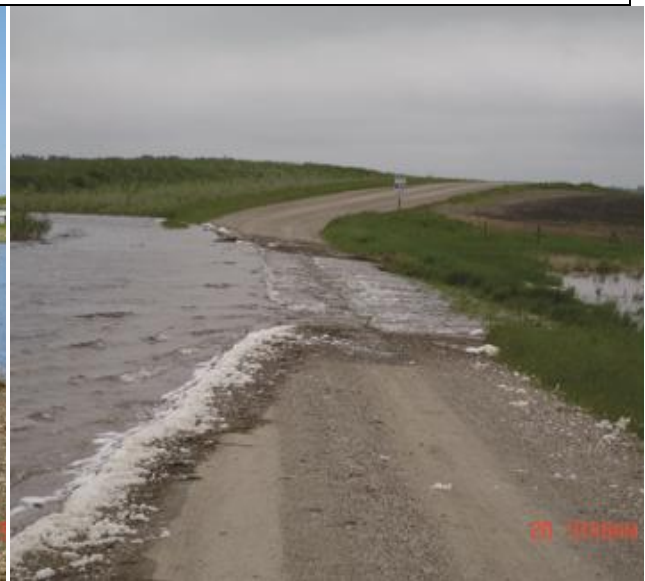
Figure 13 - Flooding and damage - South Lake 2011

Road at South Salt Lake outlet point - June20_2011

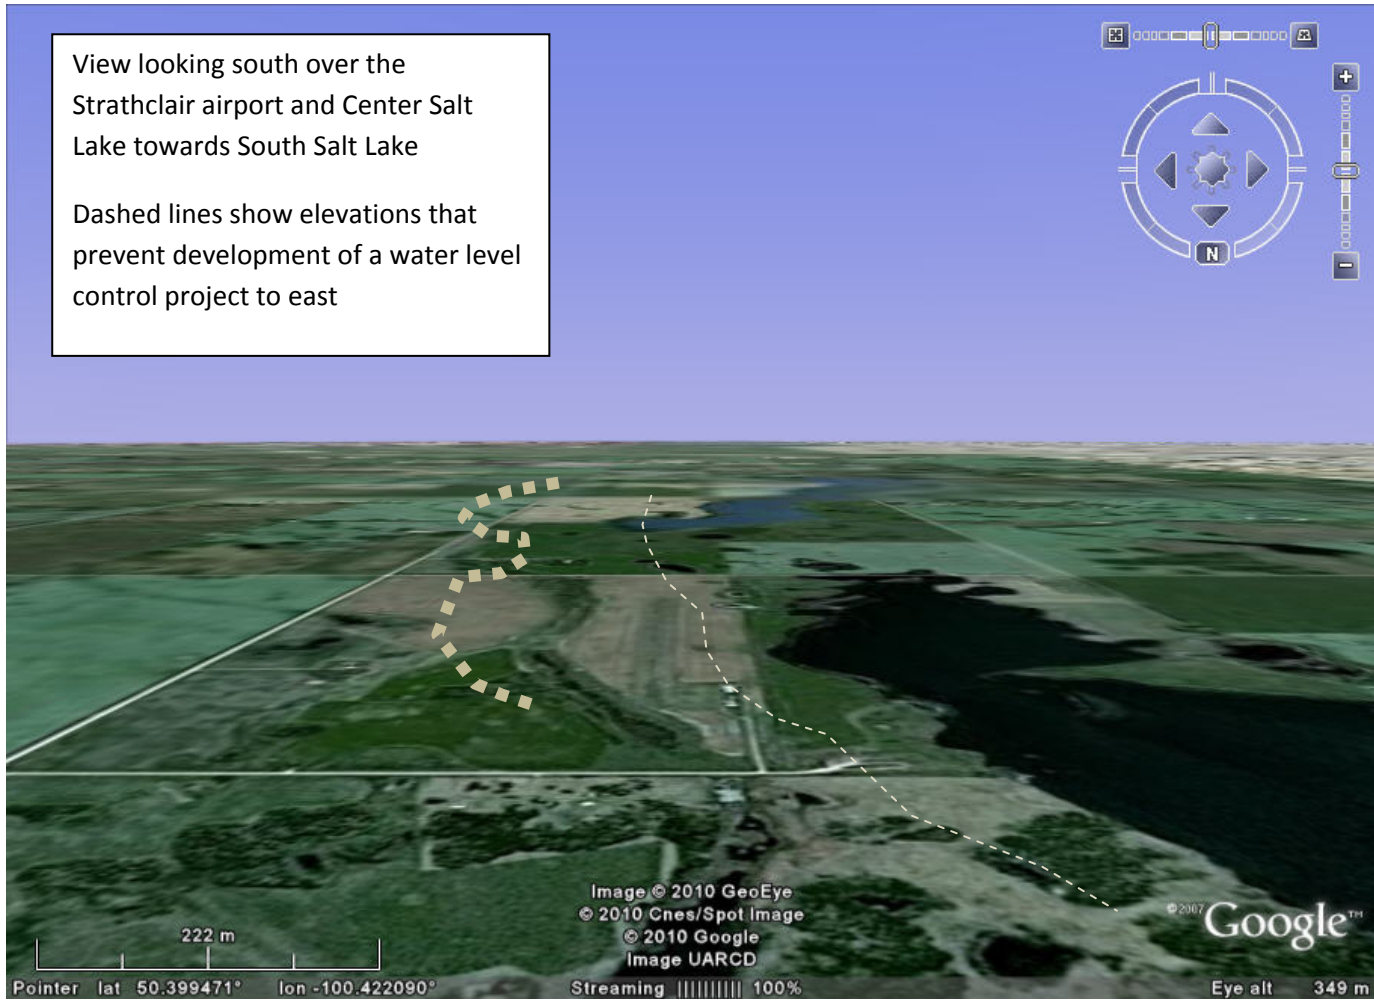
Figure 1- Bird's Eye View of Affected Area

- Highway and CPR railway intersect the north end of Central Salt Lake.
- A rolling topographical feature along the east side of the lake system isolates possible drainages and leaves the two northernmost lakes without an outlet.

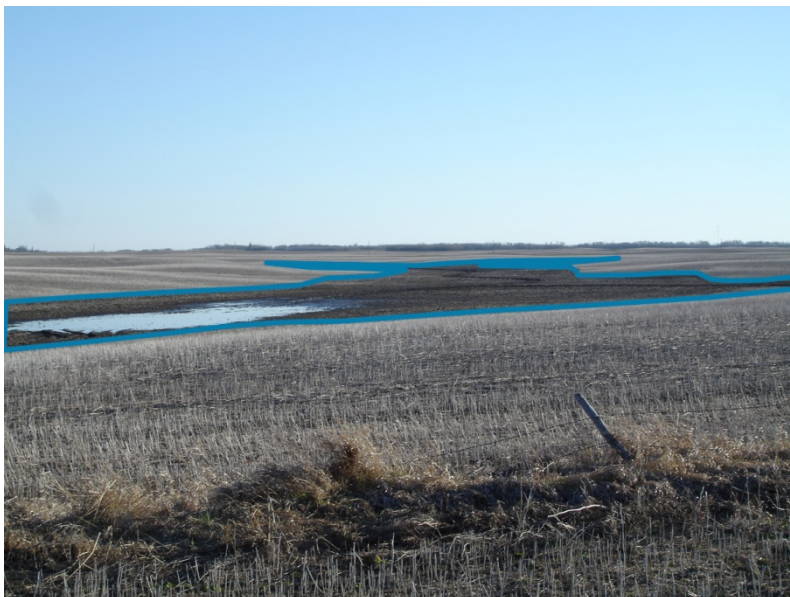
Figure 4 - East of S. Salt Lake1

Area outlined in blue revealed a massive volume of water flowed directly to S. Salt Lake from across agricultural land. Darkest areas are naked trenches and a source of silt.

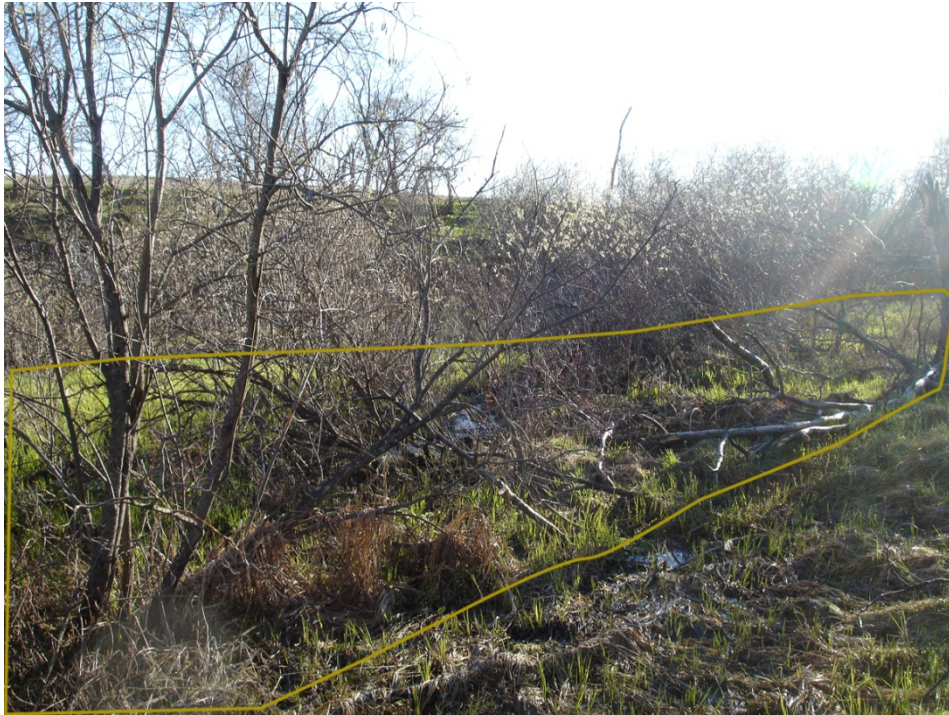
Figure 5 - Early heavy inflow to S. Salt Lake
Area outlined (light green grass) was an earlier heavy flow to S. Salt Lake

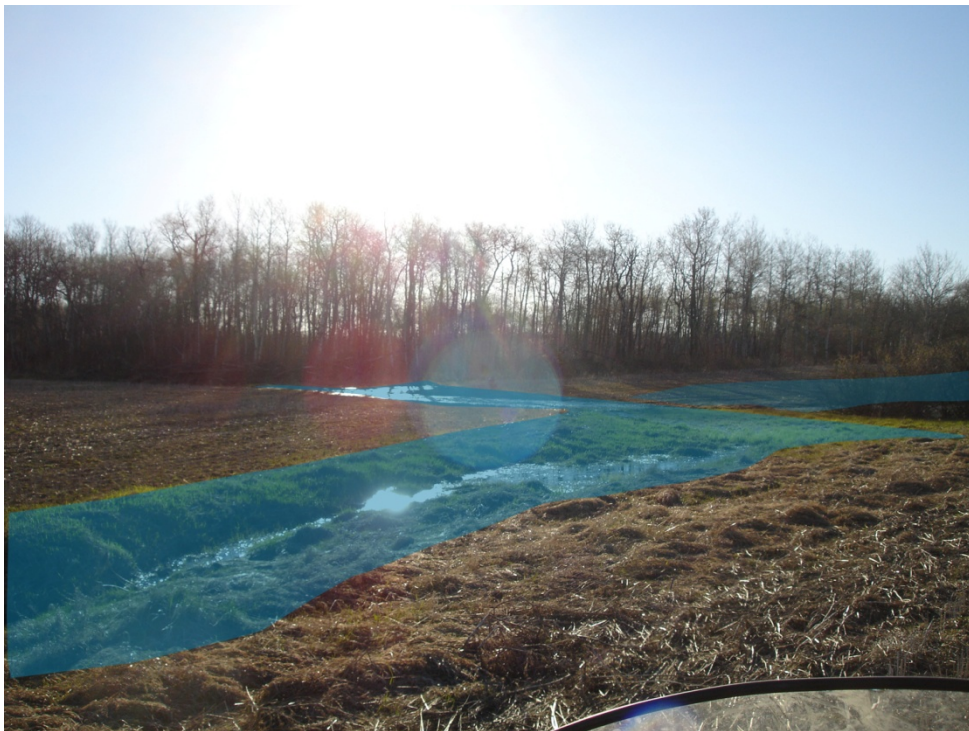
Figure 6 - S. Salt Lake source- inflow
Another heavy flow that passed on to S. Salt Lake

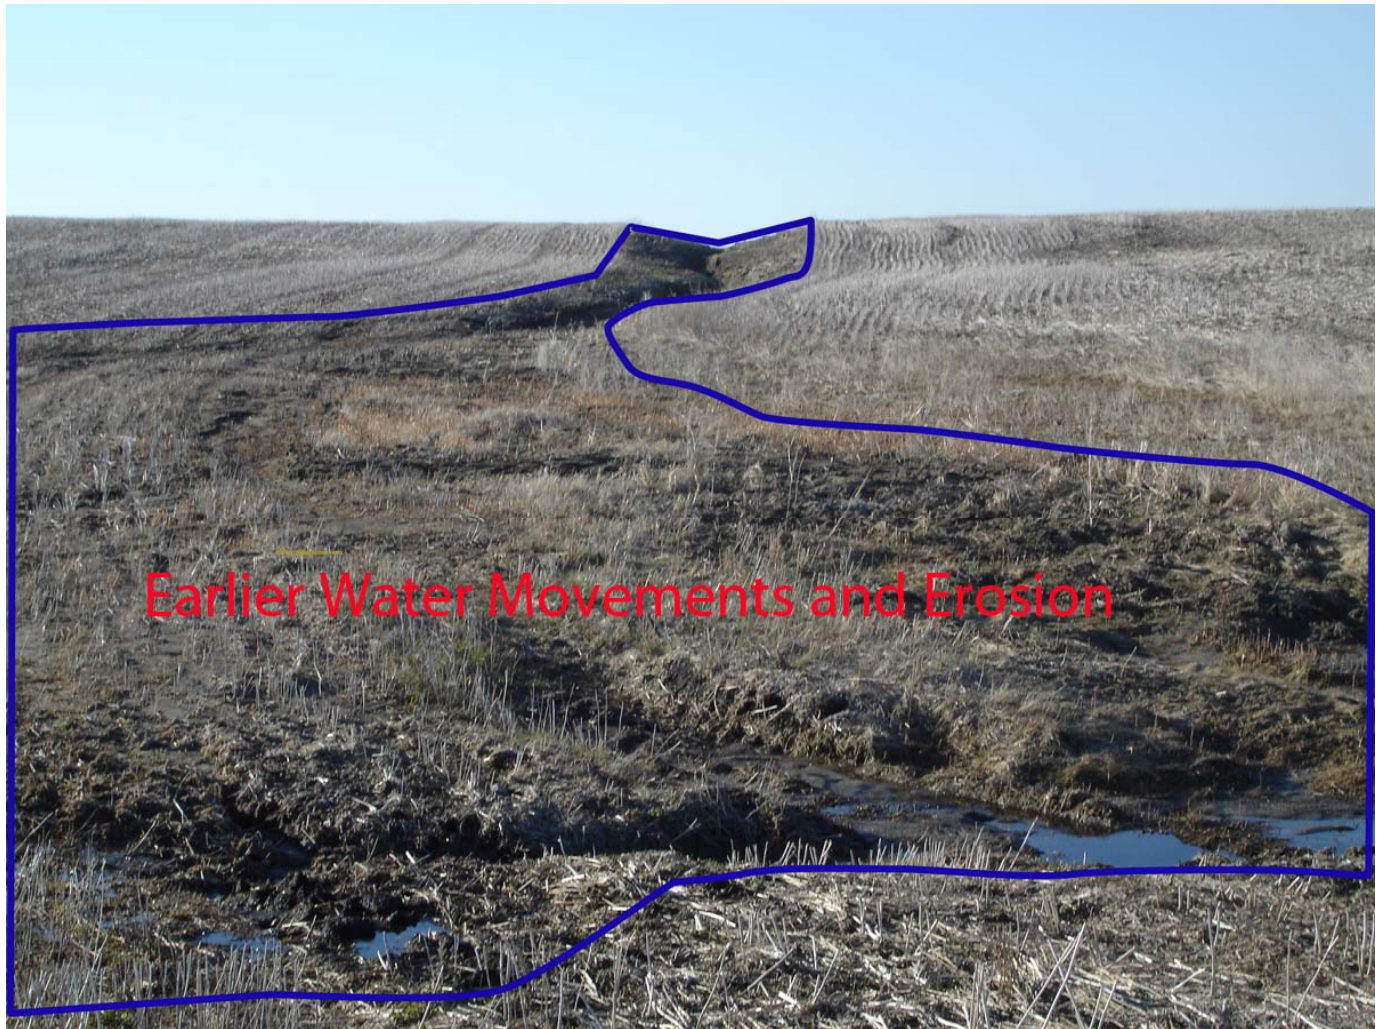
Figure 7 - Heavy Flows and Erosion (siltation)

All of this erosion ended up in South Salt Lake in early spring 2011 as silt.

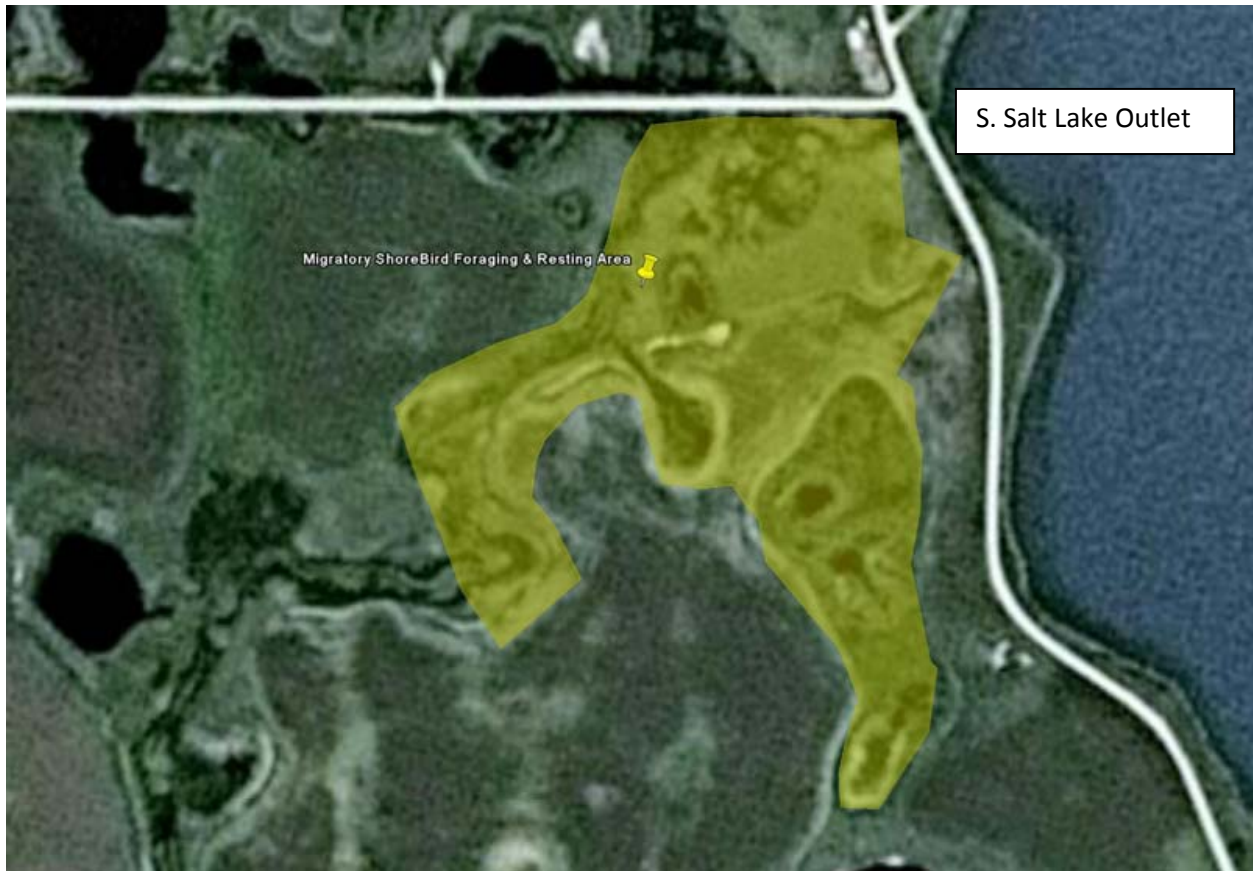
Figure 9- Area of Bird Interest

The outwash from the culvert on South Salt Lake is rich in forage that attracts varied migratory bird life.

None of these birds are endangered or even rare but it is rare to see so many of them, in such a wide variety, in such an accessible area, where birder folks can observe them from two roadways. They also appear to be rather cooperative, often resisting near approaches to flush them for wing patterns and barring to make positive identification. The following photo was taken in a channel when the S. Salt Lake road breached. Similar populations regularly flow through the culvert into the shallow broad area outlined in Figure 9.
