Table - 01: Summary of Aquatic Habitats Assessed in Project Area, 2011-2012

Stream Assessment - Site Card # LR01				
Assessment Date: June 4, 2011		Location		
Crossing # LR01		Watercourse Name Tern Ditch		
UTM 14U 6080710 N 427784 E				
		Site Description		Assessment
Upstream Waterbody: Tern Ditch Pond		Water Quality:		Fish Use
Downstream Waterbody: Snow Lake		Temp. (°C) 6.58		Spawning: Poor due to lack of suitable substrate for large-bodied fish but may provide limited habitat for forage species.
		pH 7.45		
Channel Width: 5 m		Cond (µS/cm) 161		Migration: Marginal due good connectivity to upstream habitat but low water levels may impeded passage.
Wetted Width: 5 m		Turbidity Clear		
Water Depth: 0.5 m				Rearing: Poor due to lack of suitable substrate.
Pattern: Straight				Over-wintering: Poor as this stream will likely freeze to bottom.
Characterization: Perennial				
Crown Cover: 0%		Surrounding Vegetation: Upland vegetation includes grasses and mixed forest interspersed with wetland areas.		Aquatic Habitat Sensitivity

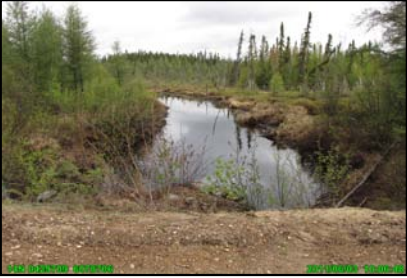
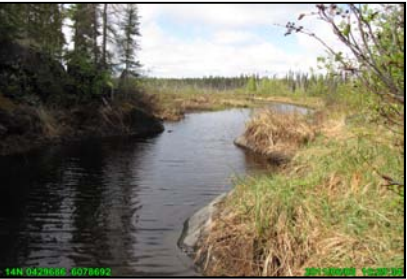
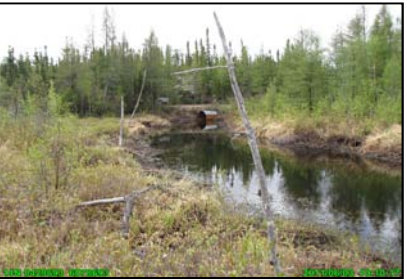
Stream Assessment - Site Card # RB02					
Assessment Date: June 3, 2011		Location

Substrate Type and Composition:	Organic		
		Cover Type and Composition:	SWD 20% OHV 5% IV 20%	Summary: Water was stagnant in and around the culverts. The current channel appears to be a diversion from the main channel to facilitate development of the rail bed. The channel provides ubiquitous, uniform habitat.	Aquatic Habitat Sensitivity
		Morphology:	Flat 100%		Low
		Culvert	Downstream Upstream	Fishing Effort: Minnow traps	Aquatic Habitat Value
		Diameter (m):	1.63 1.63		
		Water Depth (m):	0.24 0.24		
		Embedded:	No No		
		Perched (m):	~ 0.05 ~ 0.05	Species: Brook Stickleback	Marginal The limited cover and water depth may provide habitat for small-bodied species but it is unlikely that large bodied species utilize this waterway.
		Number:	2

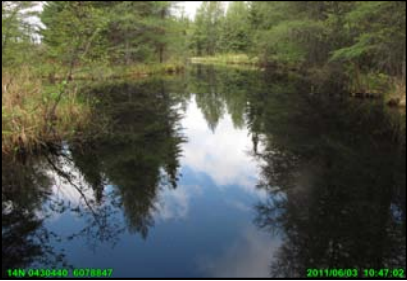
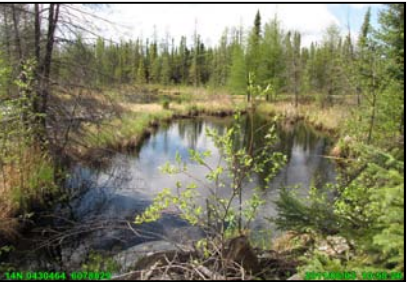
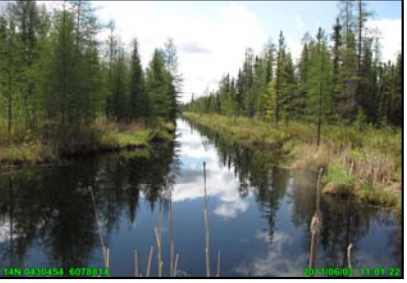
Stream Assessment - Site Card # RB03						
Assessment Date: June 3, 2011		Location

Substrate Type and Composition:	Organic	100%	Summary:	The creek is a uniform channel with organic substrate and little cover on either side of the roadway. The channel leading to Threehouse Lake is a straight channel 3 m wide and 2 m deep.
		Cover Type and Composition:	SWD	20%	Fishing Effort:	Minnow traps
			OHV	10%	Species:	Brook Stickleback
			UCB	5%		
		Morphology:	Flat	100%		
		Culvert	Downstream	Upstream		
		Diameter (m):	1.95	1.95		
		Water Depth (m):	1.56	1.5		
		Embedded:	No	No		
		Perched (m):	0.05	0.05		
		Number:	2			
					Aquatic Habitat Sensitivity	Low
						This stream is moderately susceptible to erosion and downstream sedimentation due to the soft substrate and erodible banks. However, the entire stream substrate is composed of organic fines, therefore, moderate downstream sedimentation would have little effect on fish habitat.
					Aquatic Habitat Value	Marginal
						The limited cover and water depth may provide habitat for small-bodied species but it is unlikely that large-bodied species utilize this waterway.

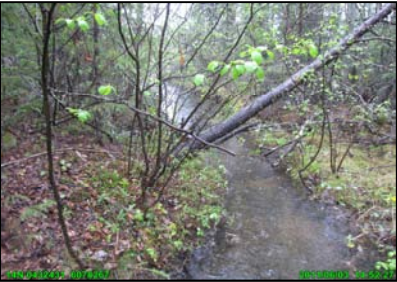
Upstream		Gaspard Creek
Figure 1: Stream crossing RB07, looking north		Waterbody:	None	Assessment
Figure 2: Stream crossing RB07, looking east, the channel follows the road until dispersing into wetland.		Downstream	Gaspard Lake	
Figure 3: Stream crossing RB07 looking southwest with some water bypassing the partially blocked culvert and crossing the road.		Channel Width:	0.5 - 1.75 m	Fish Use
		Wetted Width:	0.5 - 1.75 m	
		Water Depth:	0.32 m	Spawning:
		Pattern:	Straight	Poor for large bodied fish due to lack of suitable substrate.
		Characterization:	Perennial	Migration:
		Crown Cover:	10%	Good due to connectivity to upstream wetland.
		Substrate Type and Composition:	Organic 100%	Rearing:
		Cover Type and Composition:	LWD 5% OHV 30%	Poor due to lack of suitable substrate.

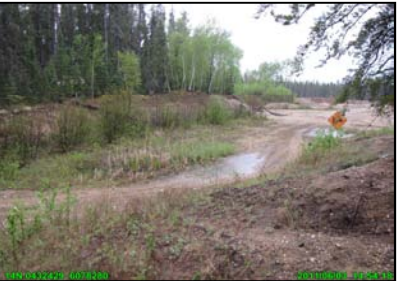
Morphology:	Flat 100%	Over-wintering:
		Culvert	Downstream Upstream	Poor as this stream will likely freeze to the bottom and not have sufficient DO to sustain fish.
		Diameter (m):	0.86 0.86	Aquatic Habitat Sensitivity
		Water Depth (m):	0.2 N/A	Low
		Embedded:	Yes Yes	This stream is moderately susceptible to erosion and downstream sedimentation due to the soft substrate and erodible banks. However, the entire stream substrate is composed of organic fines, therefore, moderate downstream sedimentation would have little effect on fish habitat.
		Perched (m):	No No	Aquatic Habitat Value
		Number:	1	No Fish Habitat
				The limited cover and water depth and lack of connection to Gaspard Lake prevent fish from utilizing this waterway.

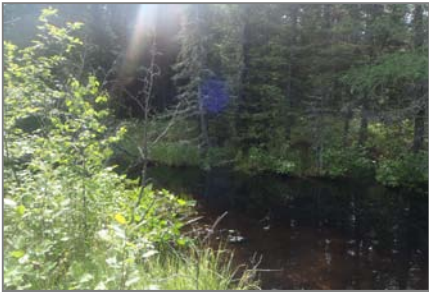
Stream Assessment - Site Card # AD03					
Assessment Date: June 20, 2012		Location

Characterization:	Perennial	Summary: The creek cuts through the soft silty, sandy substrate in the covered forest. There is limited cover and unsuitable substrate for fish in this area.	
		Crown Cover:	5%	Aquatic Habitat Sensitivity Low This stream is moderately susceptible to erosion and downstream sedimentation due to the soft substrate and erodible banks. However, the entire stream substrate is composed of organic fines, therefore, moderate downstream sedimentation would have little effect on fish habitat.	
		Substrate Type and Composition:	Fines 100%	Aquatic Habitat Value Marginal The limited cover and water depth may provide habitat for small-bodied species but it is unlikely that large-bodied species utilize this waterway.	
		Cover Type and Composition:	SWD 5% LWD 5% IV 5% OHV 5%	Fishing Effort: None Species: N/A	
		Morphology:	Flat 100%		
		Culvert	Downstream	Upstream	
		Diameter (m):	-	-
