Re: Addendum to Dangerous Goods Handling and Transportation Act Application

**Addendum to Dangerous Goods Handling and Transportation Act Application Dated June 6, 2013
– Gerdau Ameristeel Corporation – 314 Dawson Road North, Winnipeg, Manitoba**

**In Response to Questions Received from Manitoba Conservation and Water Stewardship on
June 28, 2013 via Email (Attached)**

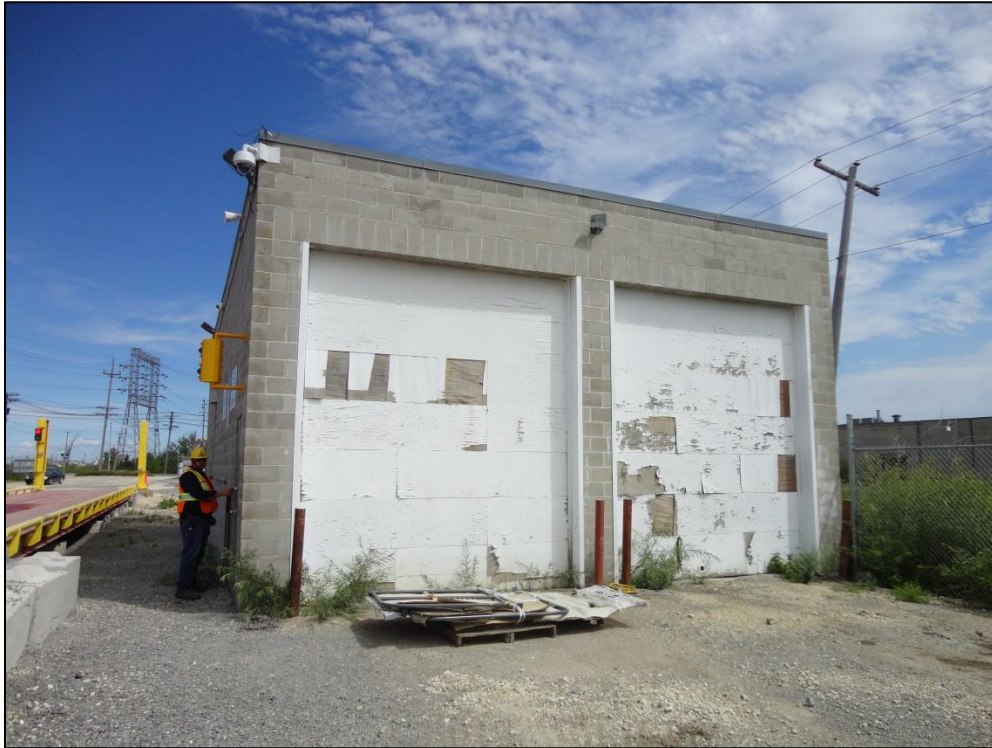
Figure 1: Two sliding doors on the exterior of the battery storage building used for loading. Due to the age of the sliding doors, they are slated to be replaced shortly.

Batteries are stored indoors within the facility until a purchaser picks them up. Loading involves moving the pallets through two sliding doors to the exterior of the building using a pallet mover (see **Figure 1**). The interior of the building comprises of a concrete pad. Due to the age of the sliding doors, they are slated to be replaced shortly. Pallets are immediately placed onto the transport vehicle. The purchaser is responsible for the loading of batteries. In case of any spillage, both Gerdau and the purchaser have battery spill kits on hand for containment and clean up (see **Figure 2**). Operators will be trained on the appropriate use of the spill kit. The majority of batteries from this site are purchased and transported by Interlake Salvage and Recycling Inc. in Stonewall, Manitoba. Interlake Salvage and Recycling Inc. is licensed to handle and transport waste lead acid batteries.

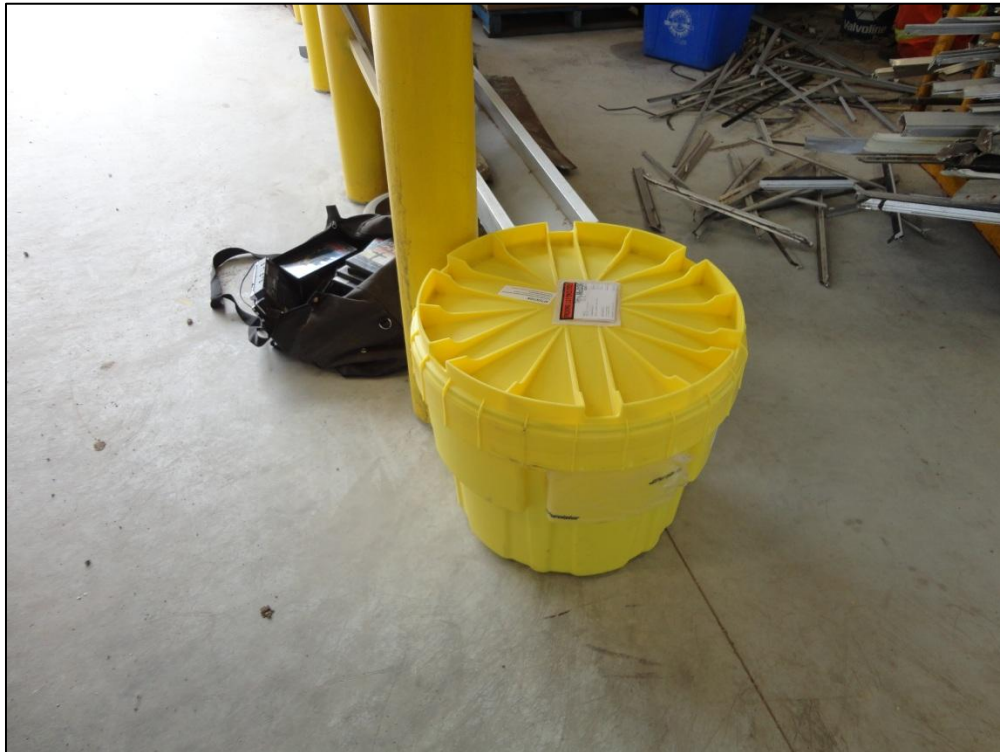
Figure 2: Battery spill kit accessible on site.

To date, since January 2013, the site has not received a broken or leaking battery. Thus, this is not anticipated to occur more than once or twice per year. An appropriate battery spill kit is available on-hand for containment and clean up (see **Figure 2**). Operators are trained on the appropriate use of the spill kit.

In the case a broken or leaking battery is identified, it will be contained immediately within a drum marked for broken batteries. An absorbent and neutralizing agent from the battery spill kit would be utilized for any spillage. Any materials used from the spill kit (e.g. soiled absorbents) will be disposed of appropriately. Disposal will be handled by a licensed hauler (e.g. Miller Environmental) if it does not meet the standards for office waste or municipal solid waste (which is picked up by BFI). Once full, the contained drum for broken batteries will be picked up by a licensed hauler (e.g. Interlake Salvage and Recycling Inc.) for appropriate recycling and management.

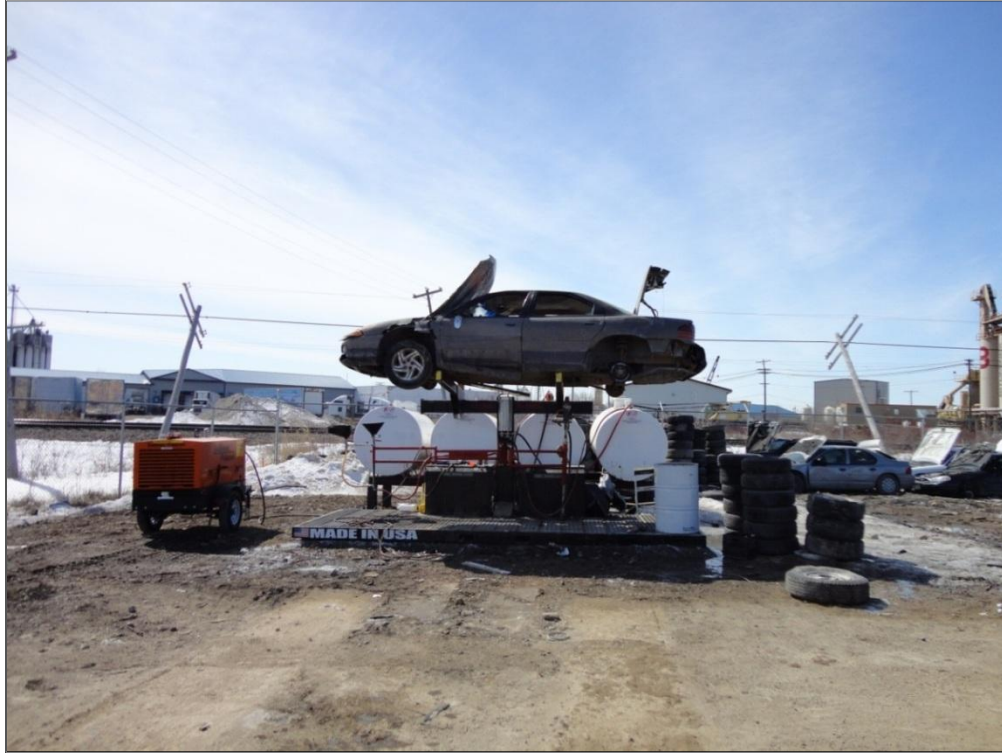
Figure 3: SEDA drain tower (fluid extraction system) located near the west perimeter of the site.
Waste fluids are stored in the double-walled tanks behind the system.

The fluid extraction system simply removes and appropriately stores waste fluids from scrap automobiles processed on site. A forklift places the scrap automobile onto the frame (see **Figure 3**) and a drill is used to puncture the tanks on the automobiles. Waste fluids are collected by the SEDA drain tower and stored in four (4) 2000 L tanks behind the system. All of the tanks are double walled for secondary containment. As the SEDA drain tower is a portable unit, the tanks are connected to the drain tower through flexible rubber hoses. Waste fluids are not extracted on days with high winds.
